**City of Burien**  
Community Center Annex

**Facility Condition Report**

**December 16, 2019**

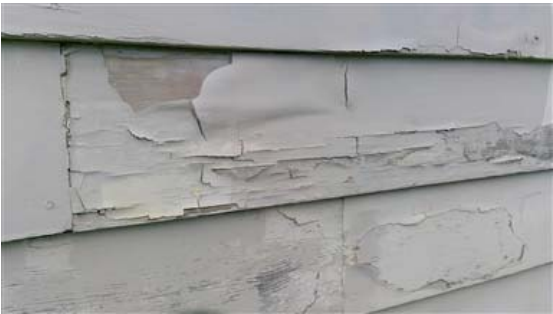
Deficient Material: Siding

Wood cladding is overall nearing end of life with some areas of paint blistering and some dry rot evident (especially at exposure zones). East exposure areas show discoloration and weathering at all nail heads.

Remove exterior cladding, provide new building wrap, and re-clad.

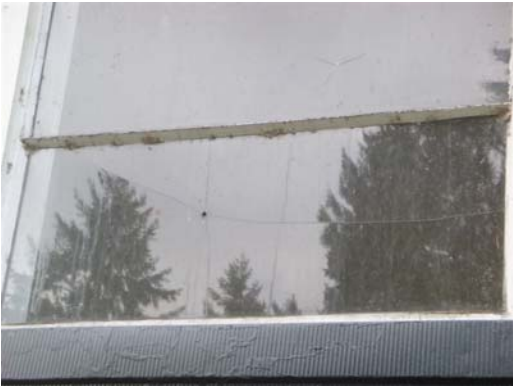
Numerous windows cracked or broken and single-pane glazing in steel frames are past end of life.

Note: Probable Hazardous Materials (Asbestos), or even PCBs suspected due to the age of the building and visual appearance of the putty stopped glazing is cracking in areas and based on age is suspected of containing asbestos.

Replace damaged glazing (test for hazardous materials and abate prior to unit replacement).

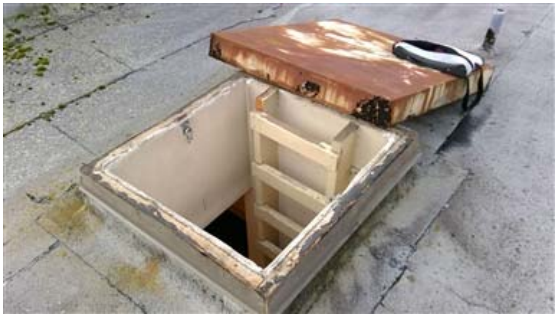
Deficient Material: Roof Openings - Hatches

The existing original roof access ladder (wood) and heavy manual wood, plaster, and metal hatch, does not meet current OSHA or life safety standards for maintenance use and safe rooftop access.

Replace all roof access ladder and hatches with modern OSHA compliant systems and add fall restraint guard around opening.

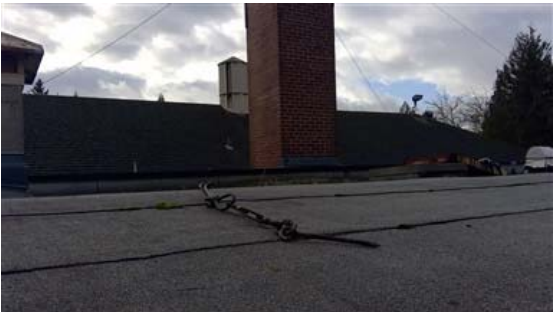
- Seismic reinforcements on the masonry chimney are failing with one anchor completely detached from the structure. Other anchors' reliability are suspect. The chimney masonry also exhibits diagonal cracking. The collapse of the chimney in a seismic event could cause personal injury, and would likely destroy the building's roof, interiors, and boiler, creating other significant safety hazards.

- Seismic reinforcements on the masonry chimney are failing with one anchor completely detached from the structure; others anchors are suspect. The chimney masonry also exhibits diagonal cracking.

One of the four corner seismic retrofit cable stays has ripped loose. Based on the attachment method, other restraints are suspect. Additionally, cracks are evident above the roof that are very concerning. The chimney should be evaluated for seismic safety and verification it is not a life safety hazard.

Have a structural evaluation conducted and correct seismic bracing (or remove masonry chimney).

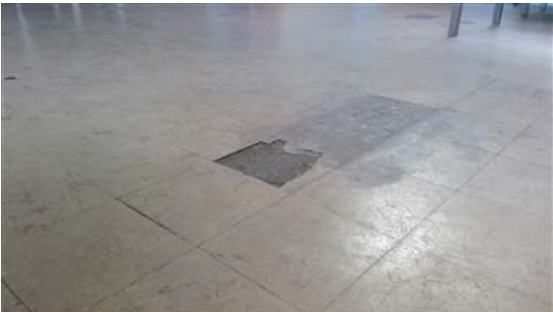
Areas of 9 x 9 tile broken and popping loose.

Note: Probable hazardous materials (asbestos) in tile, floor, and base adhesives suspected due to the age of the building, tile unit size, and visual appearance. This is especially a concern in Classroom 5, that appears to be in use and exhibits some of the worst conditions.

Test for asbestos in tile and adhesives. Abate or encapsulate if asbestos is present.
