CITY OF BURIEN SHORELINE MASTER PROGRAM UPDATE

SHORELINE INVENTORY

MARCH 27, 2008
REVISED OCTOBER 23, 2008

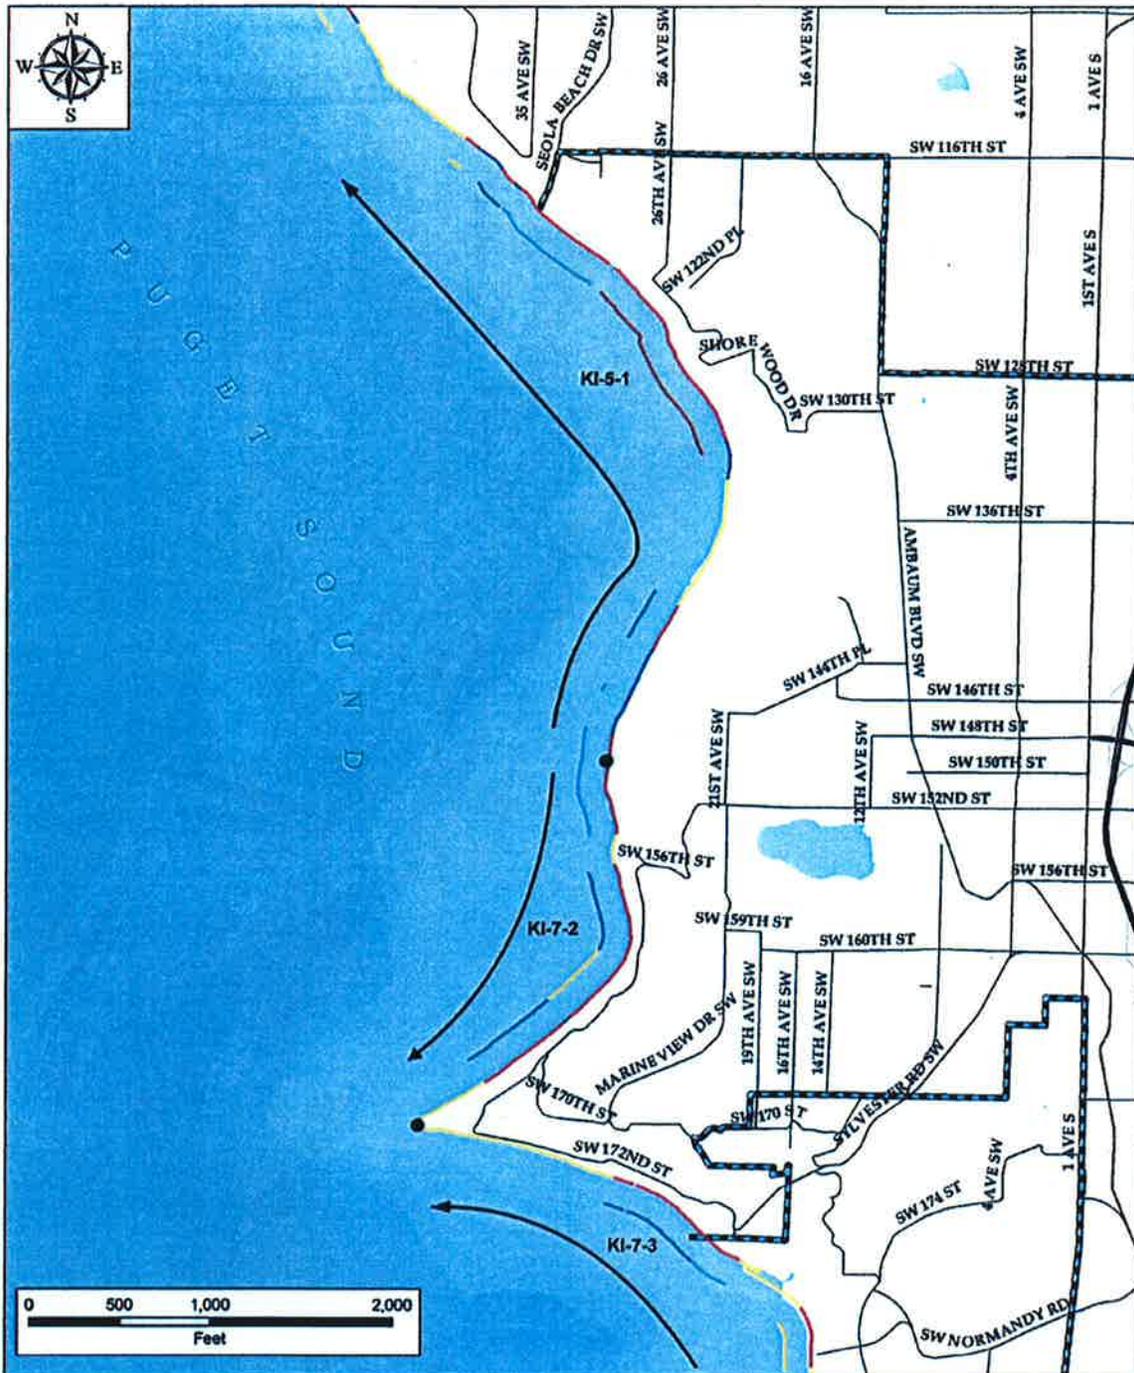
Data Source: Inventory and Assessment of Current and Historic Beach Feeding Sources/Erosion and Accretion Areas for the Marine Shorelines of Water Resource Inventory Areas 8 & 9

Burien is located within the Nearshore Sub-watershed of Water Resource Inventory Area (WRIA) 9. Eighty (80) percent of the shoreline has been modified within the Nearshore Sub-watershed. Most shoreline modification measures (such as seawalls and bulkheads) were installed to protect residential development from erosion. However, these shoreline modifications have resulted in the alteration of nearshore habitat functions; examples include interruption of habitat-forming processes, destruction of habitat, and degradation of sediment and/or water quality. Within WRIA 9, there are only a minimal number of unaltered shorelines (Kerwin and Nelson 2000, Johannessen, MacLennan, and McBride 2005). Burien's shorelines include part or all of three marine drift cells (KI-5-1, KI-7-2, and KI-7-3) which historically included both erosion (e.g., feeder bluff) and accretion (e.g., beaches) shoreforms but have now become extensively modified (Figure 4A, Johannessen, MacLennan, and McBride 2005).

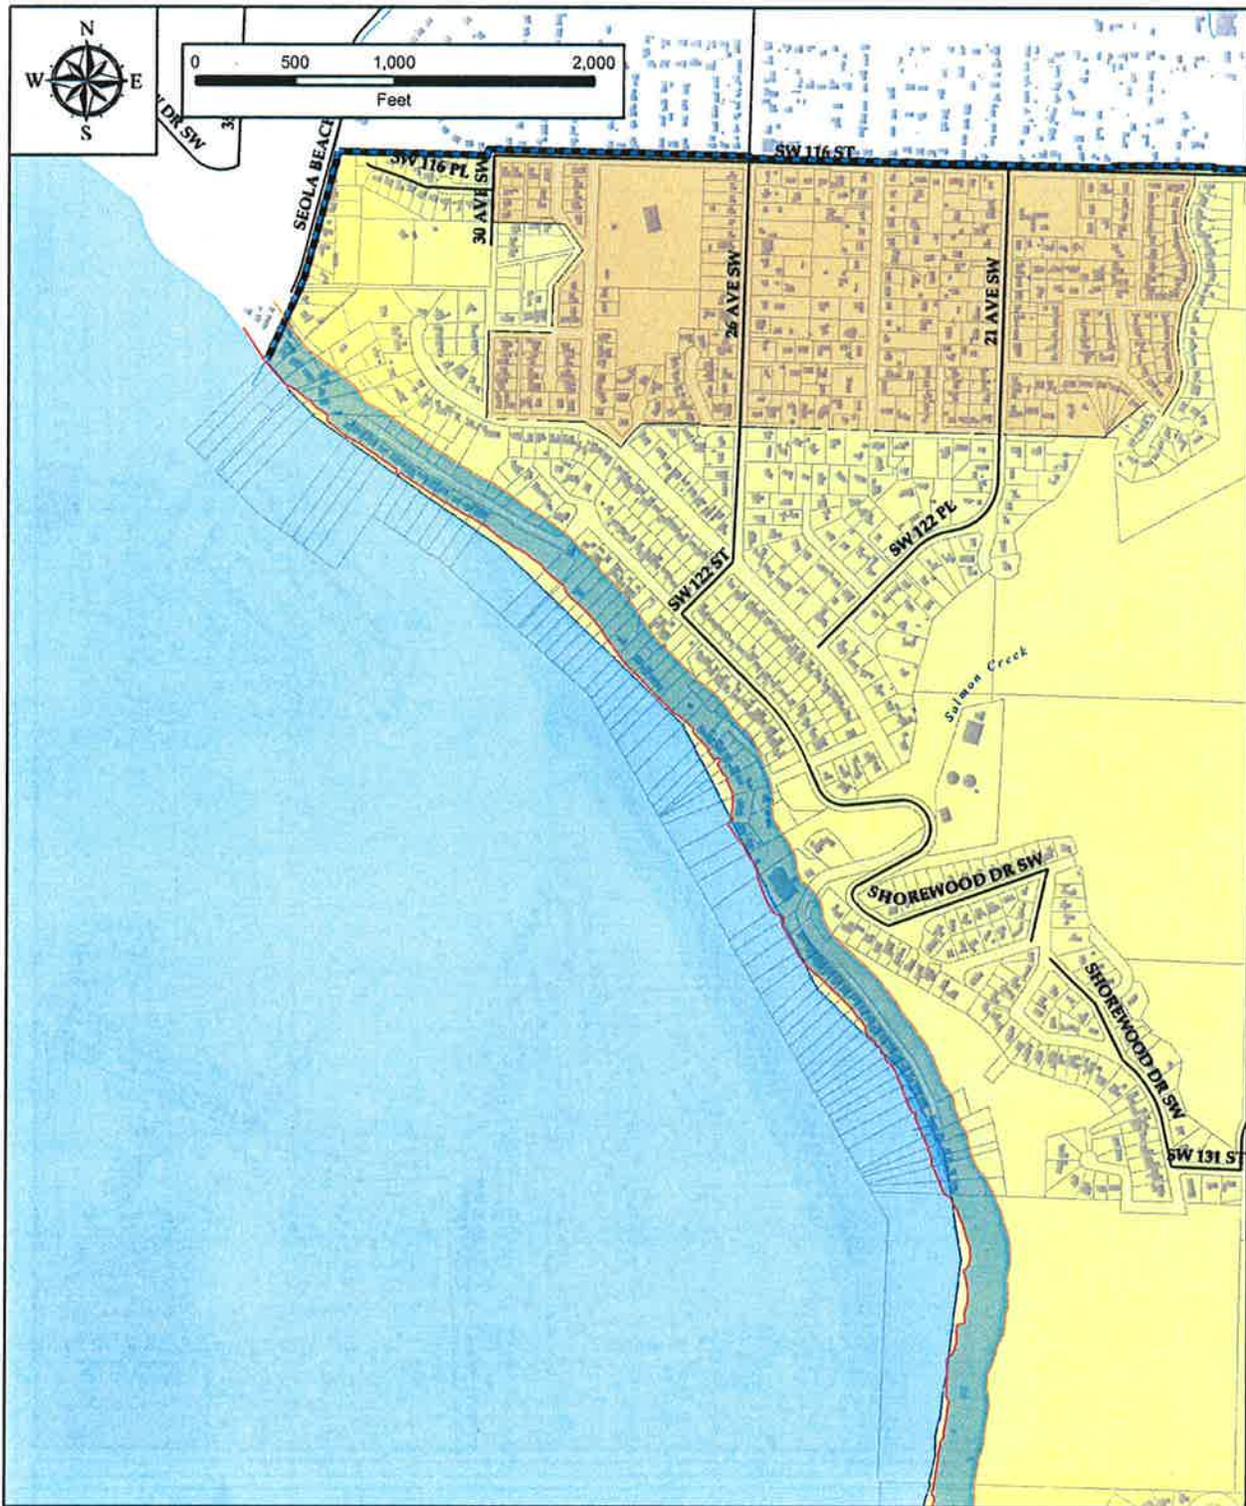
Date: May 04, 2009 Figure 6A

City of Burien
Shoreline Master Program
Zoning
Marine 1

The City's most current Zoning Map (2007; Figures 6A-6E) includes 18 zoning designations. However, only three zoning designations apply within the shoreline area. Two of these are residential single family. The third zoning designation is the Special Planning Area 2. The entire marine shoreline is zoned RS-12,000, which allows detached single family homes with a minimum lot size of 12,000 square feet. The majority of the Lake Burien shoreline is zoned RS-7,200, which allows detached single family homes with a minimum lot size of 7,200 square feet.

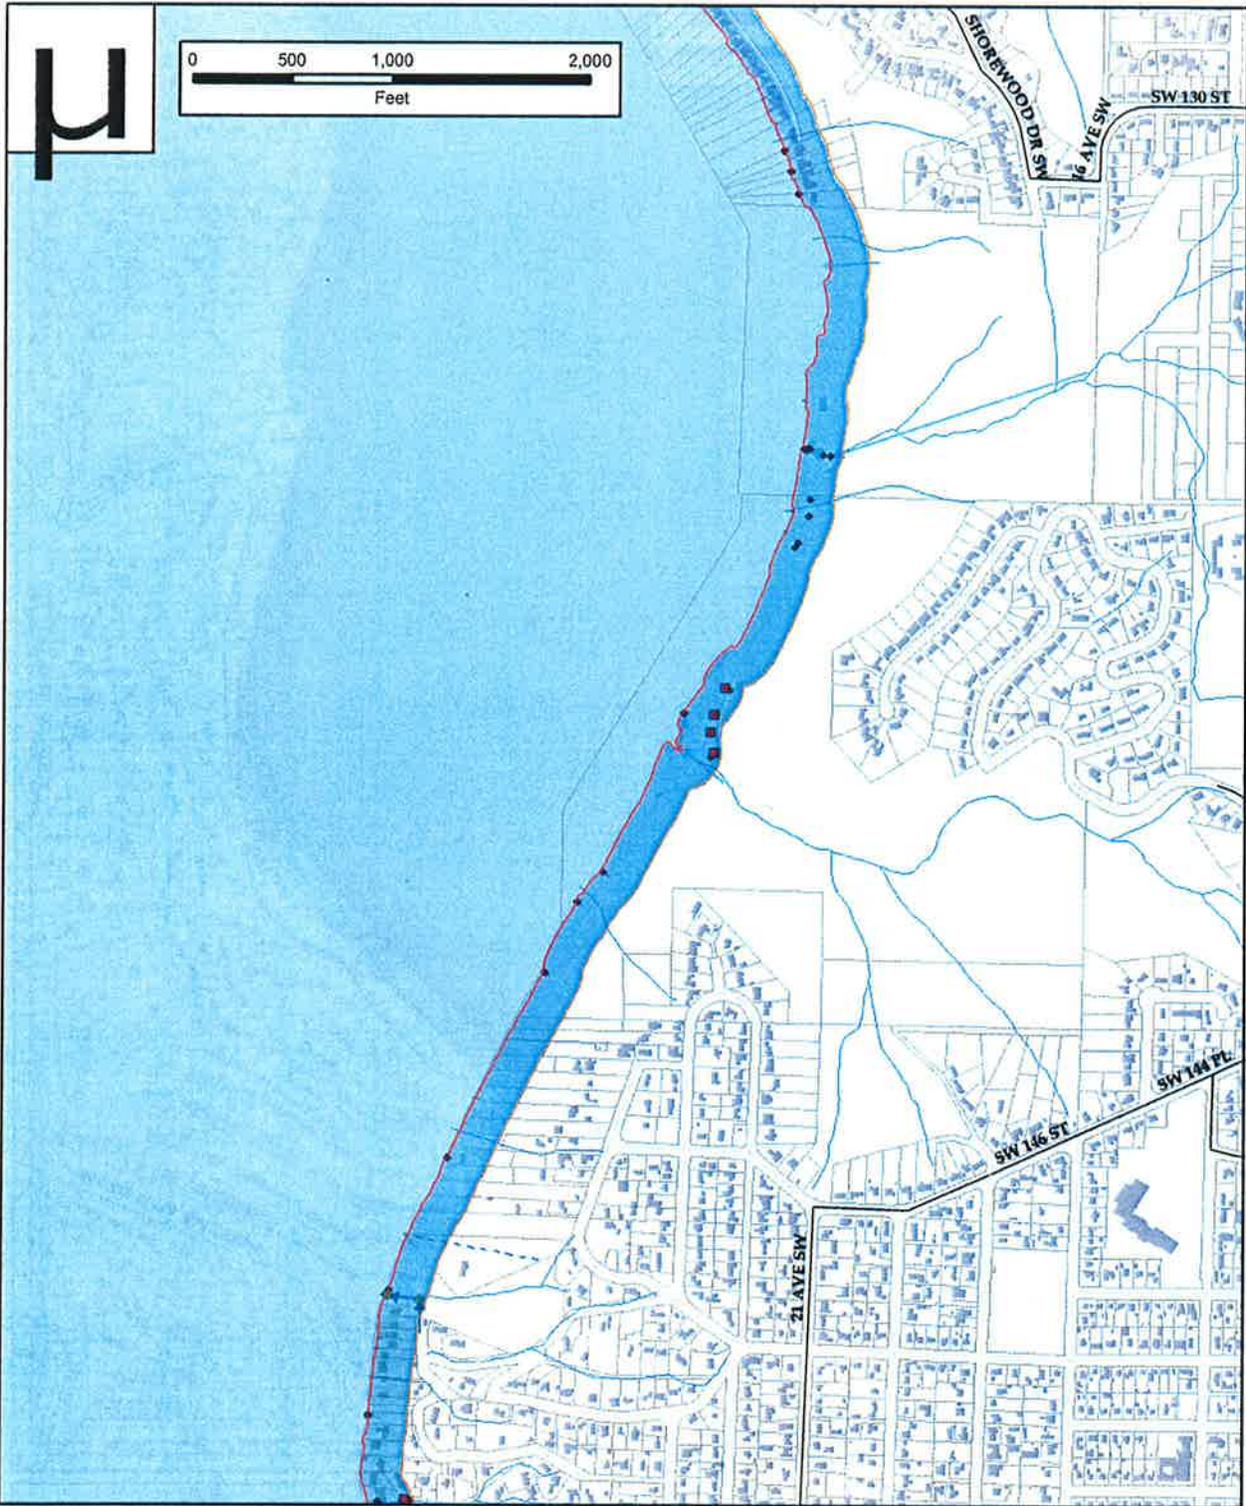
Figure 7A

Boundary of Burien	Catchbasin Reach	* CB Type 1 Infiltration	Salmon Creek
Buildings	TYPE	Y CB Type 1 Inlet	Miller Creek
Reaches	\$ Type 2 Flow Splitter	I CB Type 2	Small Creek
Lake Burien	- Other	+ Type 2 FROP	Open Flow
Marine 1	⚡ Downstream Defender	I CB Type 2 Infiltration	Bioswale
Marine 2	U Pump Station	(Type 2 Inlet	Sheet Flow
Marine 3	2 Stormfilter Vault	4 Type 3 Infiltration	Ditches
Marine 4	7 CB Type 1	N Type 3 Vault	Storm Pipes
	S Type 1 FROP	• No Data	
		• Other	
		D Joint

Drainage along the shoreline has been affected by varying degrees of development, and in some cases involves culverts. Seola Creek (which runs along the northern City limit) drains to the marine shoreline (Reach M1) through a culvert (Wild Fish Conservancy 2003). Additionally, there are some culverts associated with water draining from the small hatchery complex at the north end of Seahurst Park (Wild Fish Conservancy 2003). Along the residential shorelines in Burien, occasional small culverts (e.g., 12-inch pipe culverts) drain water from the properties onto the beaches (Wild Fish Conservancy 2003). The storm pipe culverts within the shoreline jurisdiction (marine reaches and on Lake Burien) are shown on Figures 7A-7E.
