CITY OF BURIEN SHORELINE MASTER PROGRAM UPDATE

SHORELINE ANALYSIS AND CHARACTERIZATION

JUNE 12, 2008

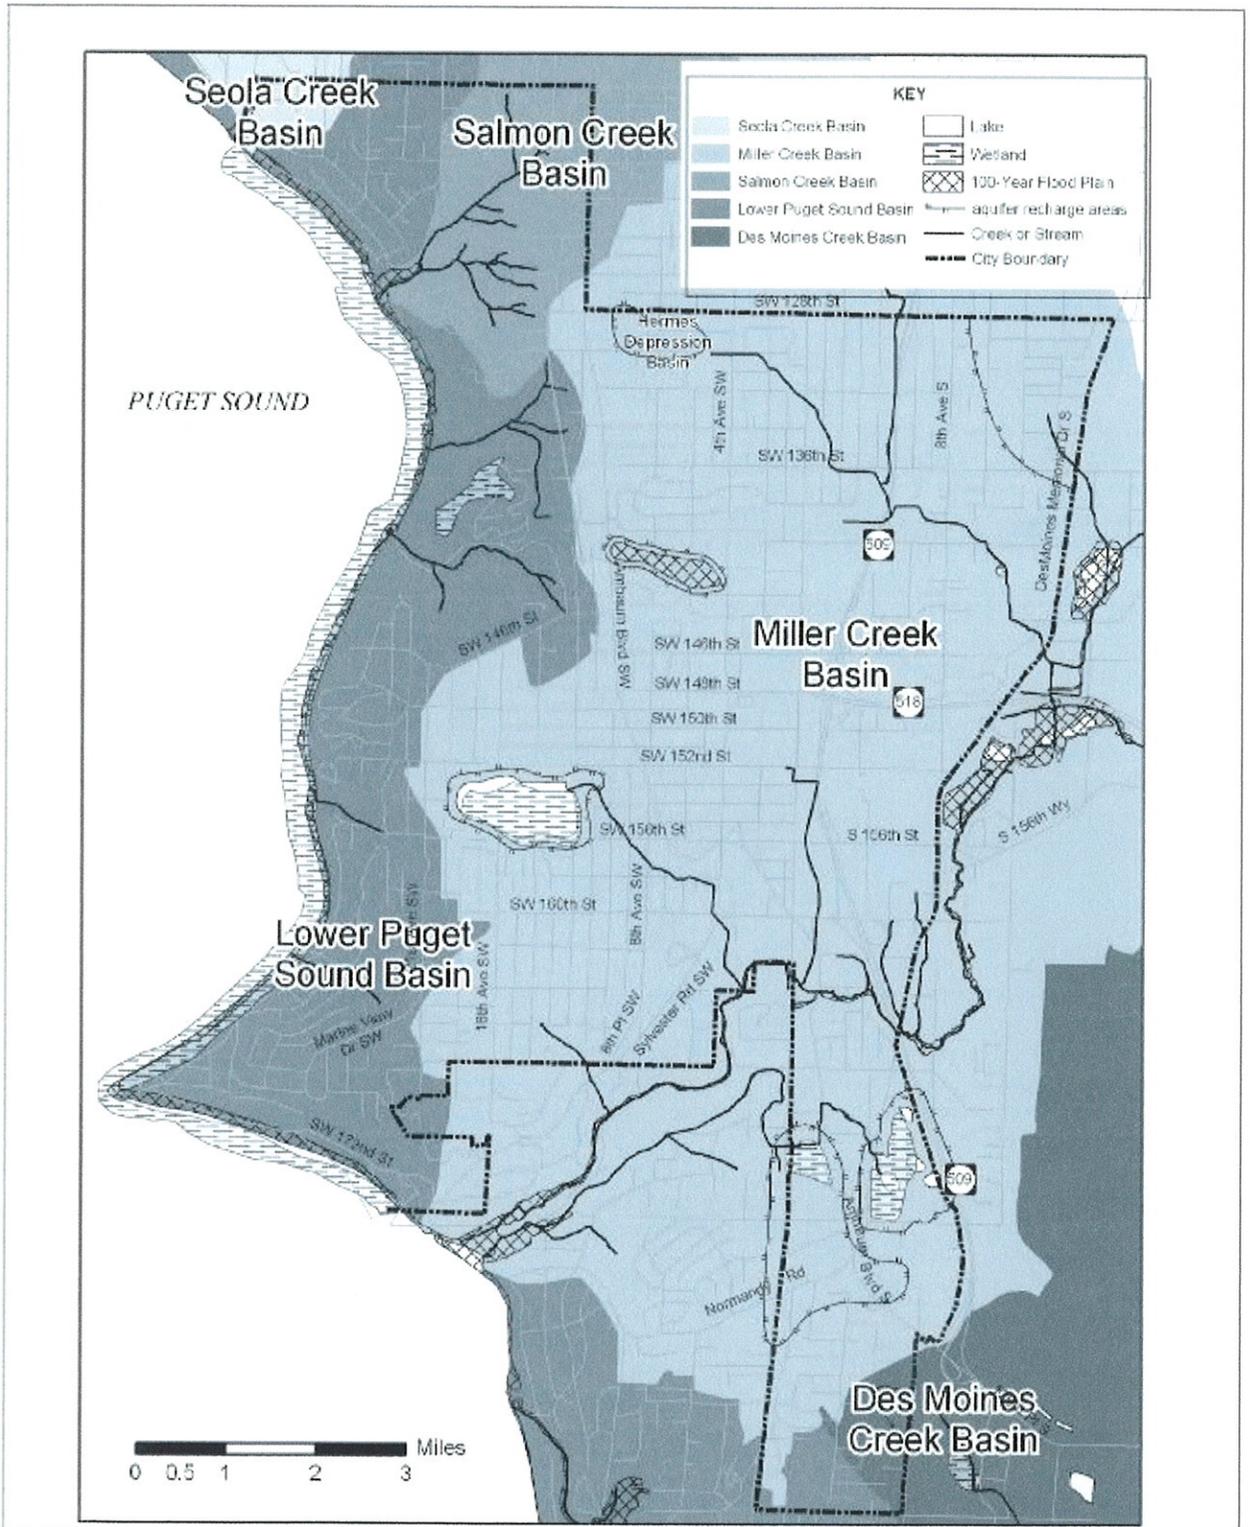
Figure 2 Natural Hydrologic Features/Drainage Basins

The City of Burien is located within three major drainage basins: Salmon Creek, draining approximately 1,390 acres; Miller Creek, draining approximately 5,230 acres; and Puget Sound (City of Burien 2006). Additionally, Seola Creek (which runs along the northern City limit) drains to the marine shoreline through a culvert (Wild Fish Conservancy 2003). Drainage is predominantly to the west towards Puget Sound.

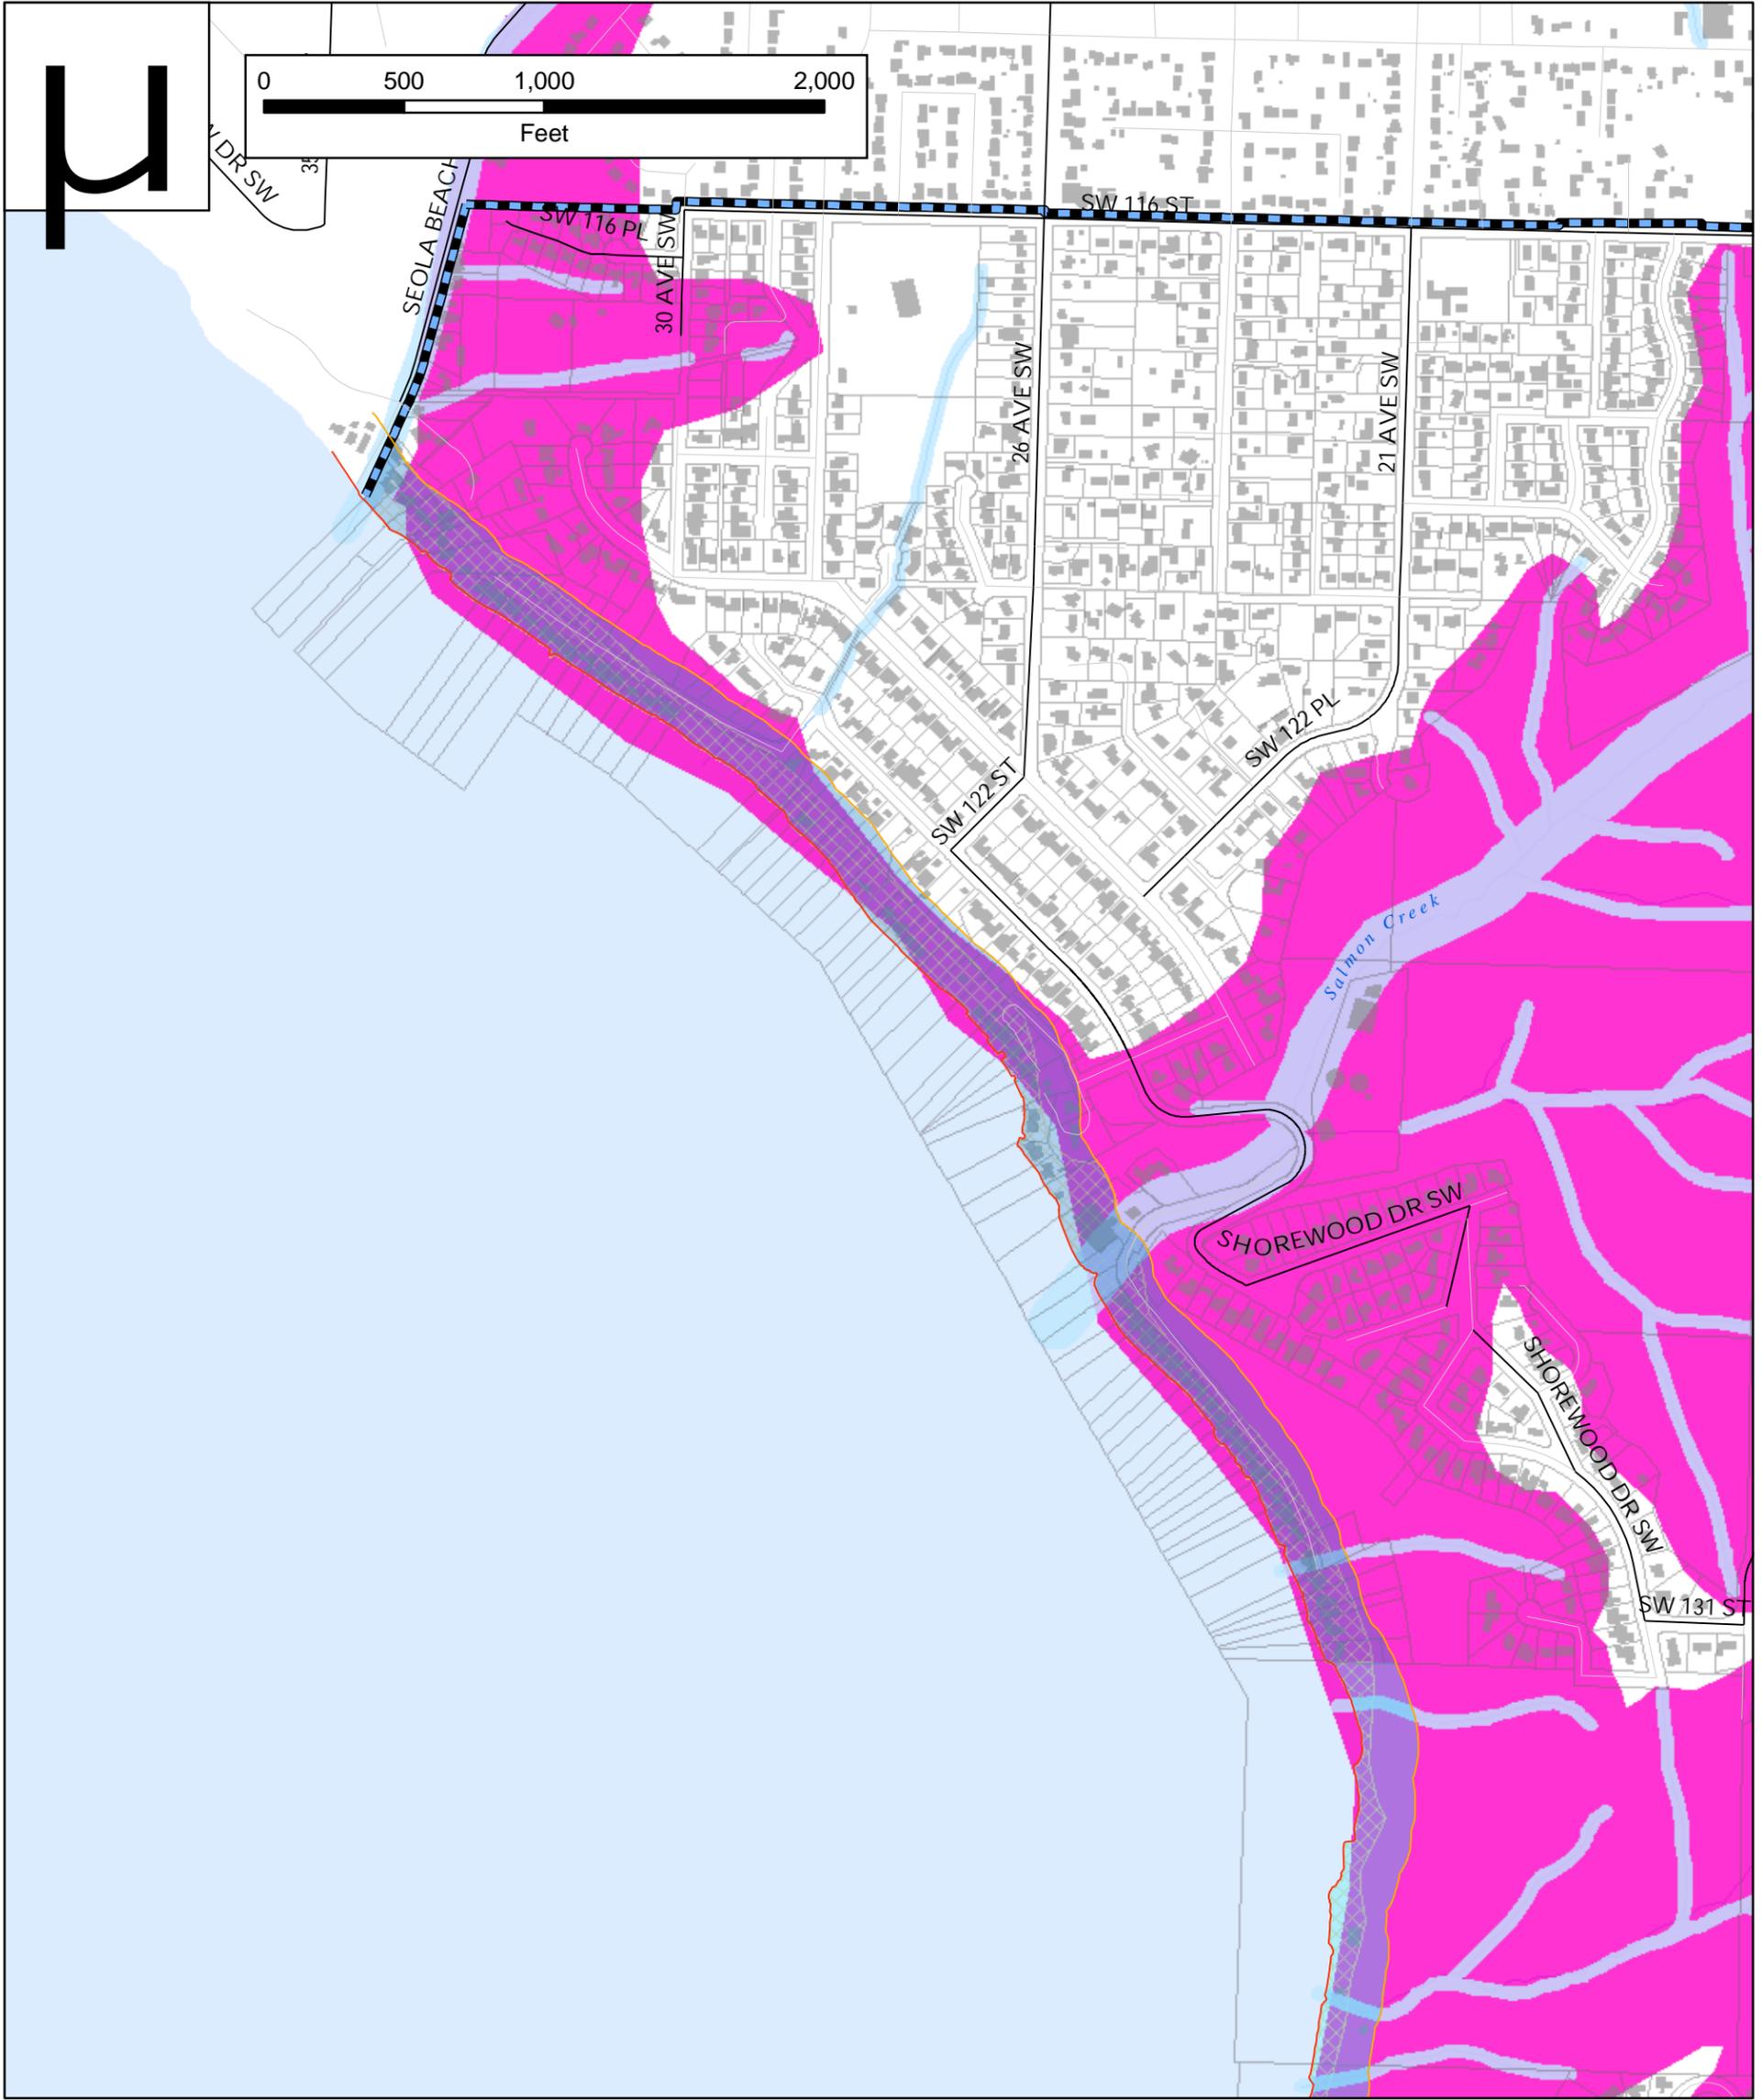
Date: Mar 04, 2008 Figure 7E

While a system of storm water drainage pipes has been installed to divert runoff flowing into the lake, several drainage points into the lake remain (Figure 7E; City of Burien 2006) and the lake still functions as a water storage area. Lake Burien is mapped as an Aquifer Recharge Area, a Critical Area (Figure 8E). Alterations to the surface conditions within an Aquifer Recharge Area associated with development, such as changes in impervious surface area, channeling of runoff and changes in the soils, can affect the rate and quantity of water entering the aquifer. Additionally, contamination of waters within the Aquifer Recharge Area can adversely impact the entire aquifer.
