# DATA ANALYSIS REPORT

## Lake Burien, Washington

Herrera Environmental Consultants  
2200 Sixth Avenue, Suite 1100  
Seattle, Washington 98121  
Telephone: 206.441.9080

**Existing Conditions of Burien Marine Shoreline  
Prepared on Behalf of the Burien Marine Homeowners Association**

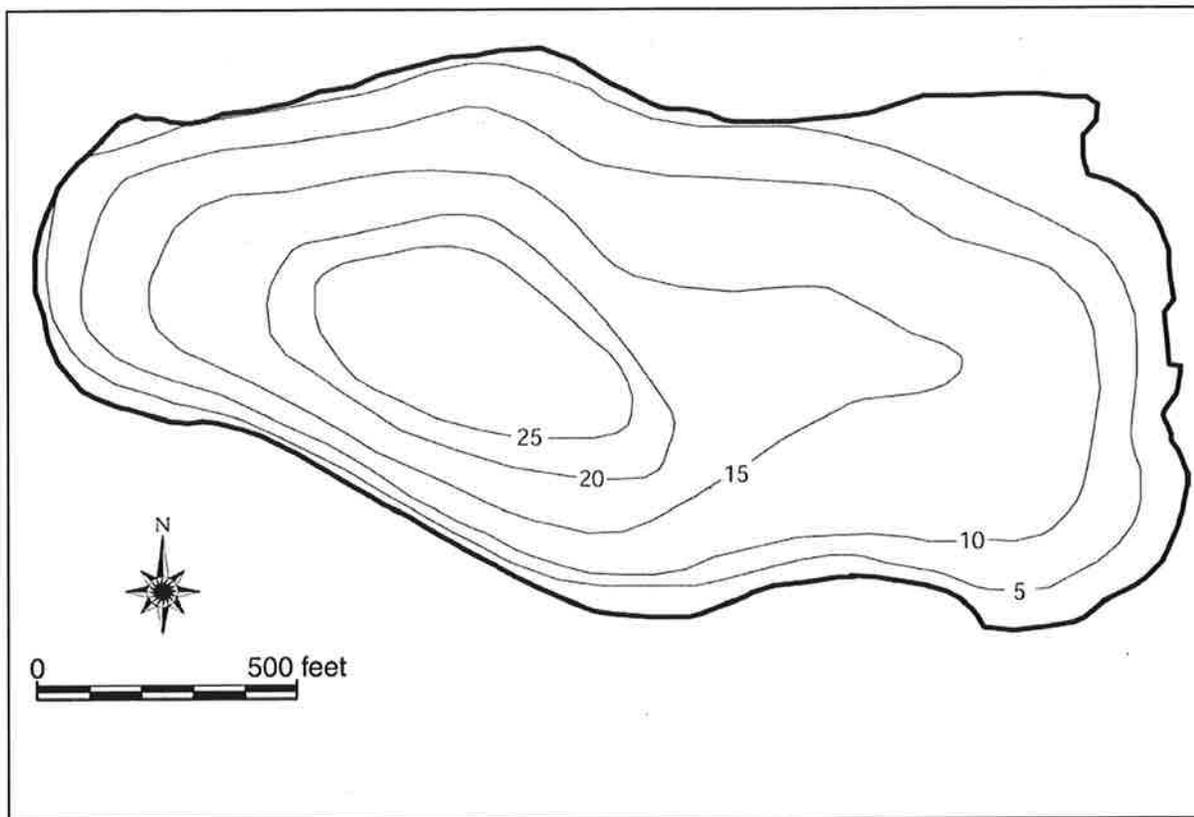
Figure 1. Lake Burien bathymetry showing depth contours in feet (source: Messick 2010).

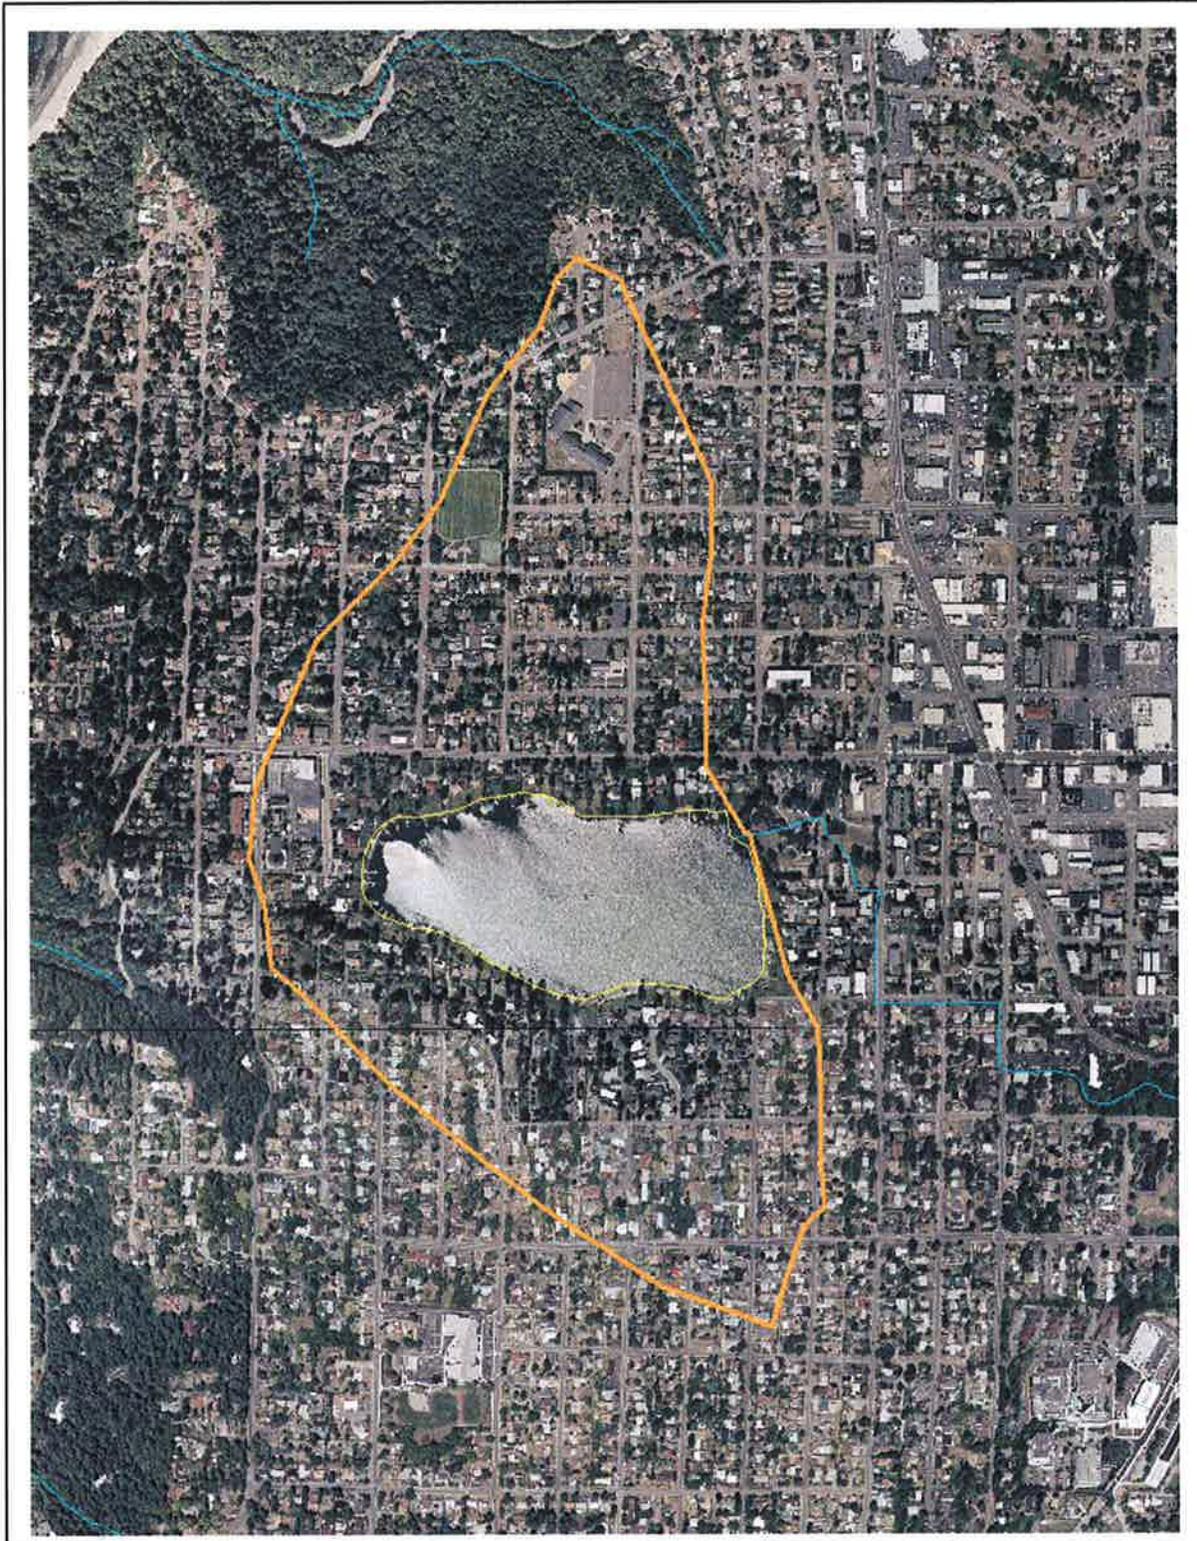
**Figure 2. Lake Burien watershed (source: Messick 2010).**

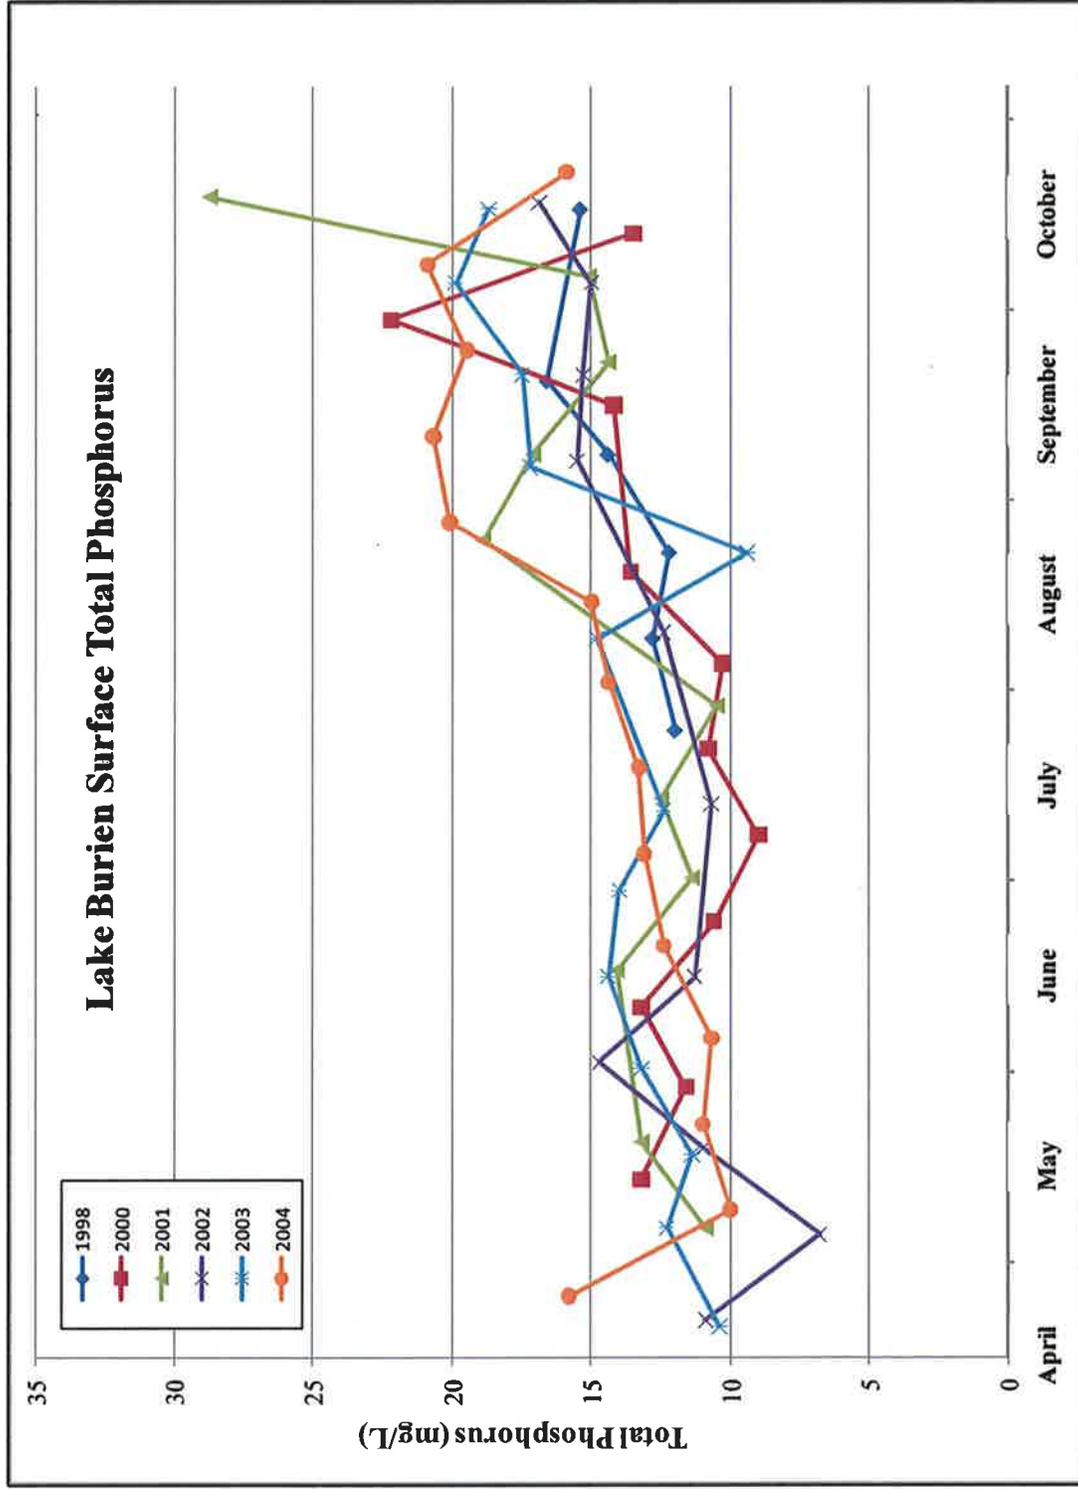
Figure 3. Lake Burien total phosphorus concentrations at 1 meter depth (source: King County 2010).

Surface (1-meter depth) phosphorus concentrations in Lake Burien typically ranged from 10 to 15 micrograms per liter (ug/L) in April through July, and typically increased to a range of 15 to 20 ug/L in September and October (see Figure 3). A minimum concentration of 7 ug/L was observed in May 2002 and a maximum concentration of 29 ug/L observed in October 2001.

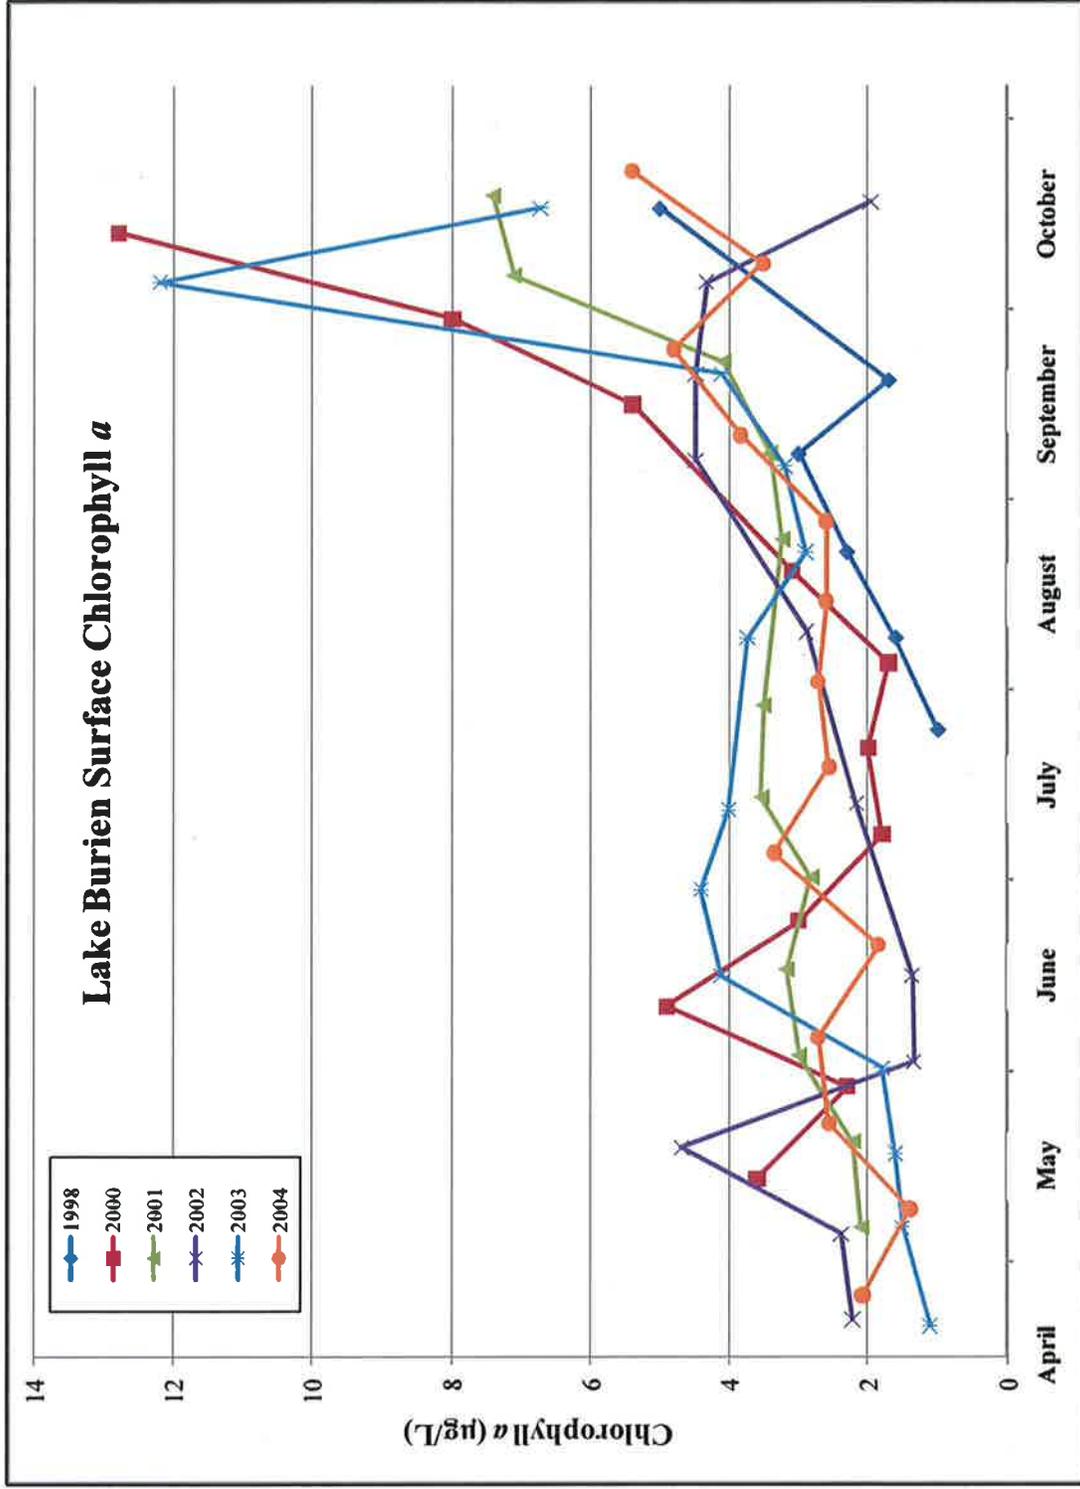
Figure 4. Lake Burien chlorophyll *a* concentrations at 1 meter depth (source: King County 2010).

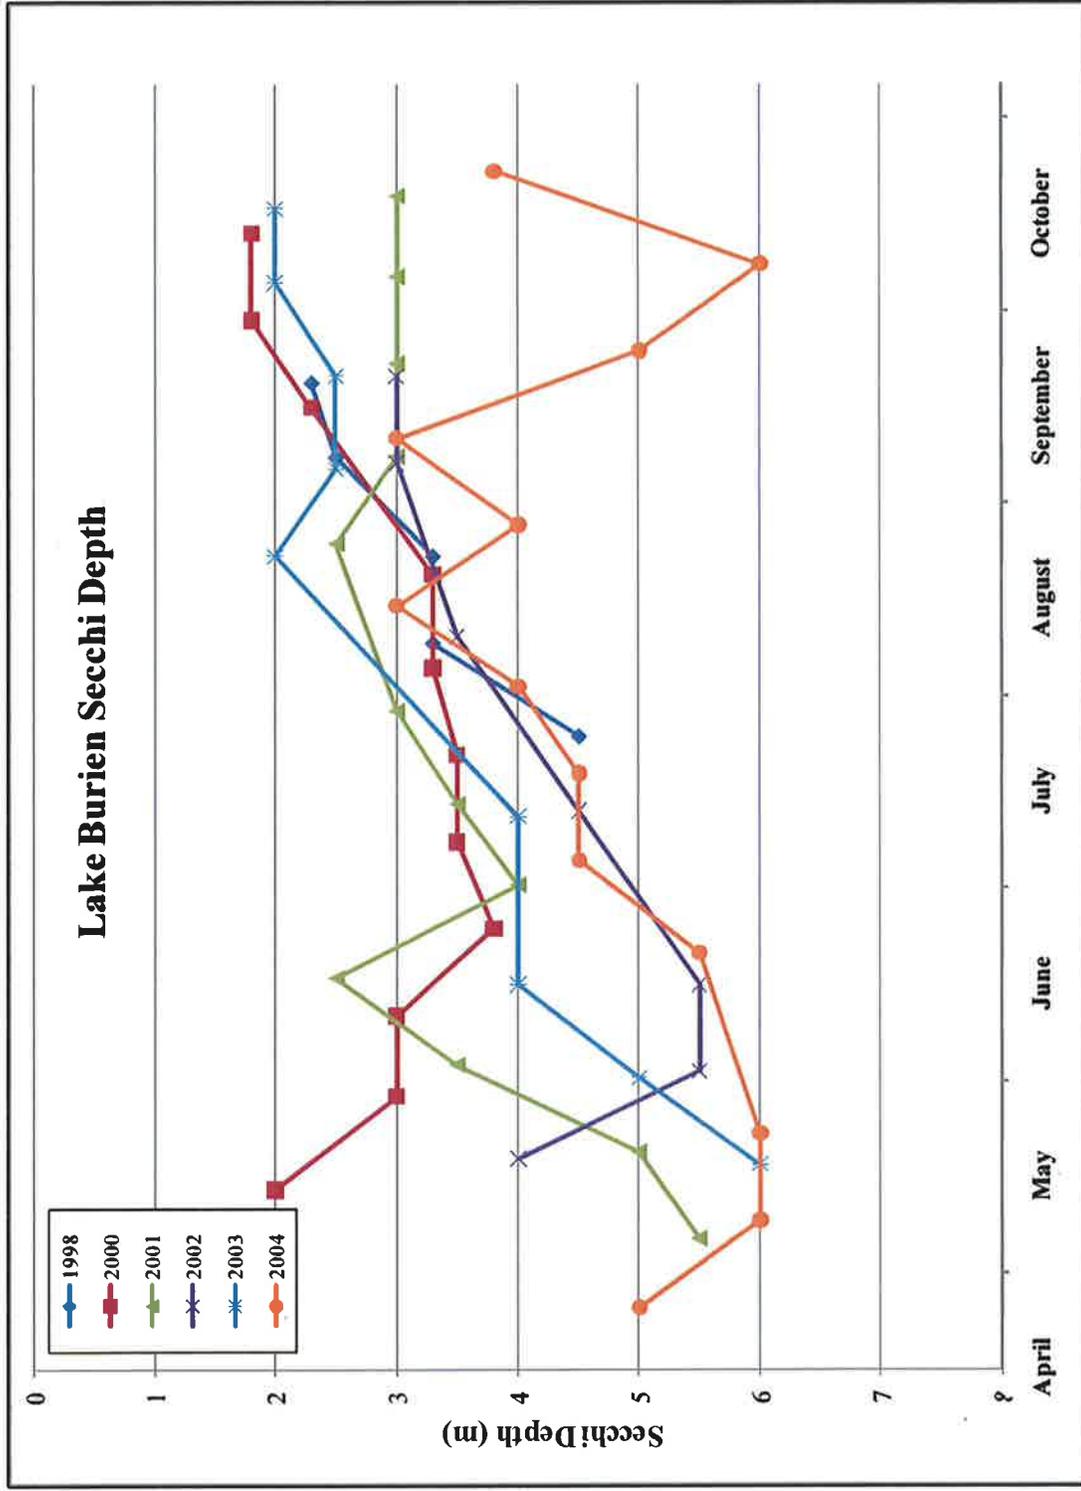
Figure 5. Lake Burien Secchi depths (source: King County 2010).

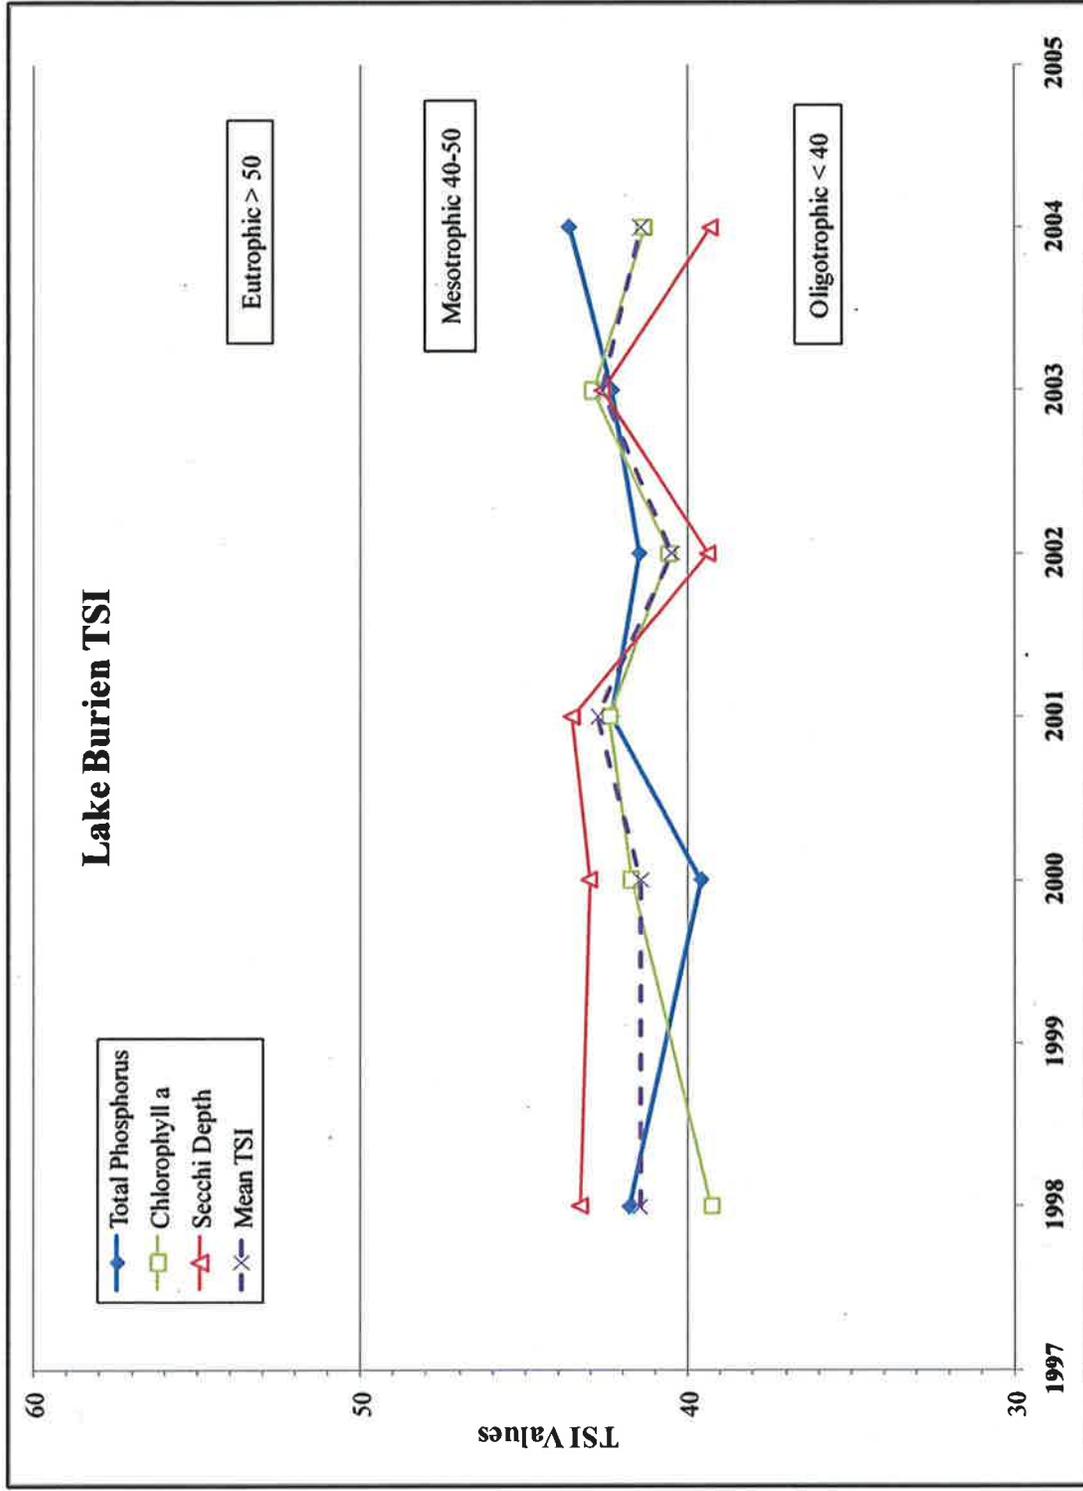
Figure 6. Lake Burien trophic state indices.

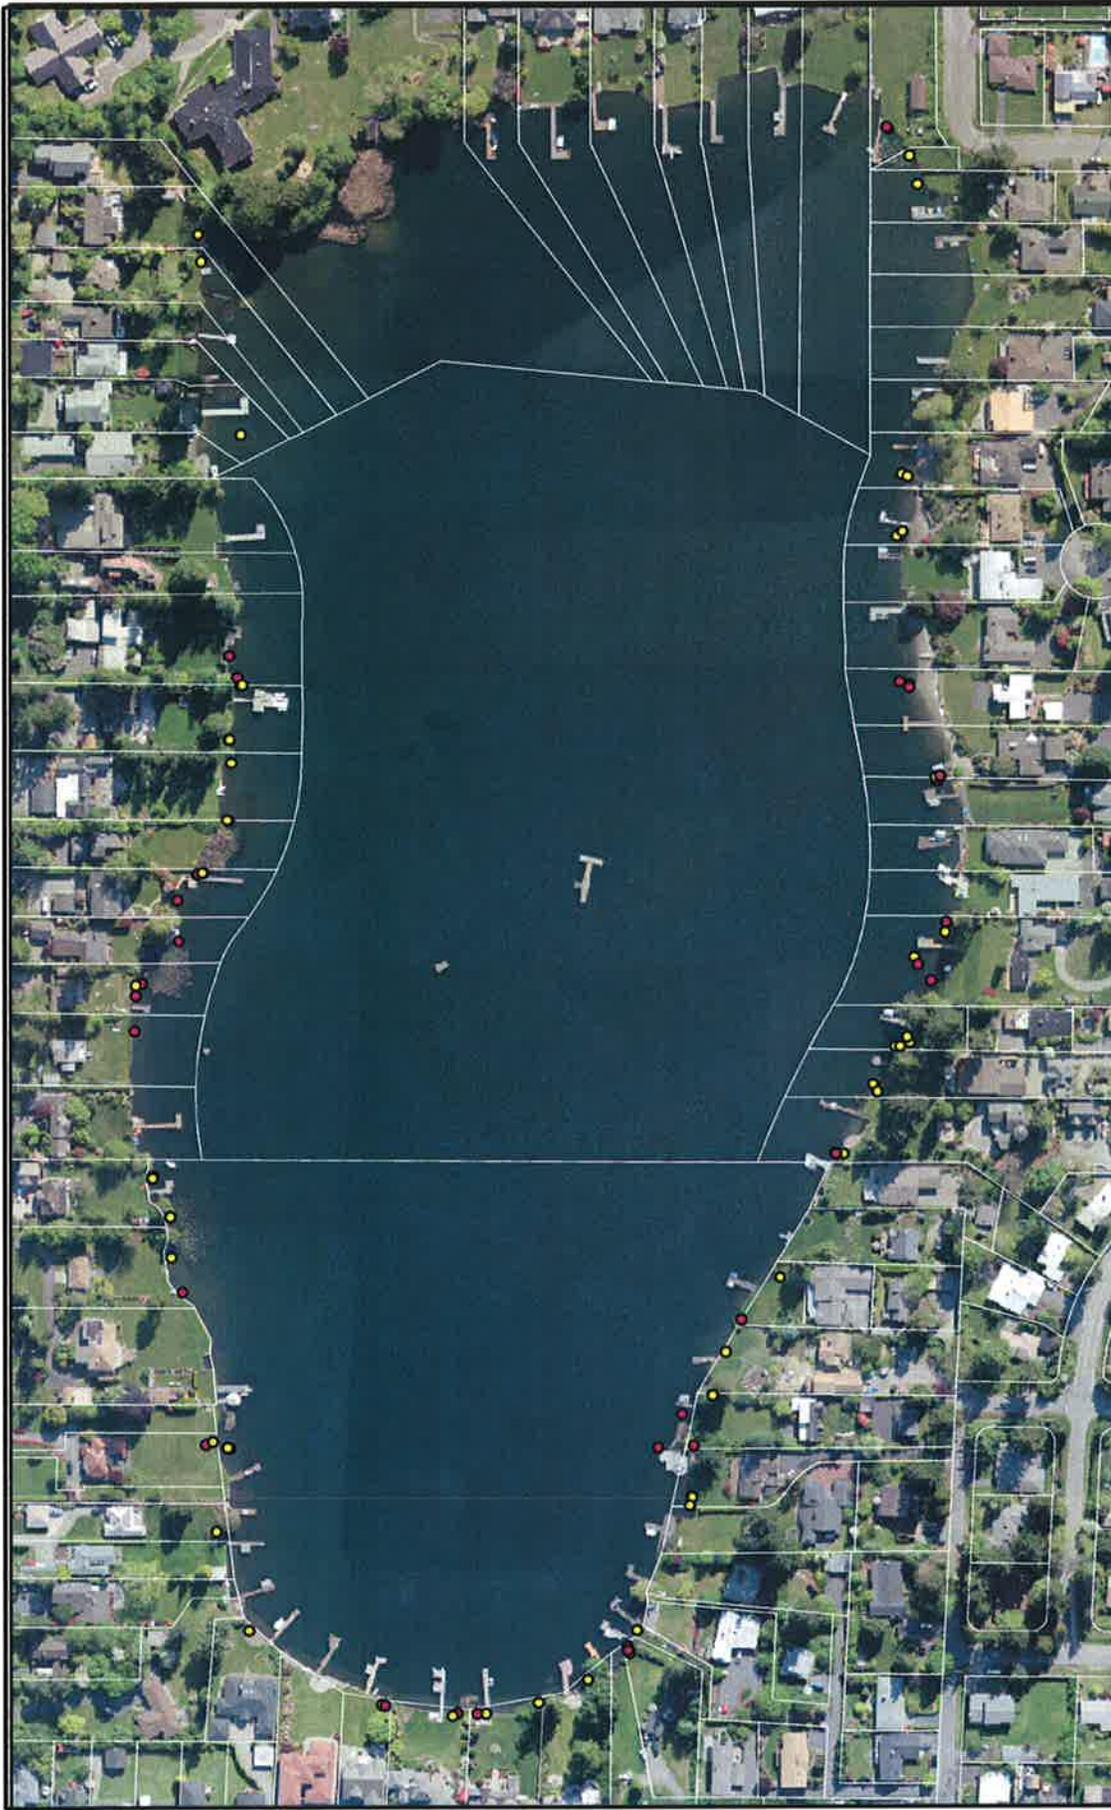
## Purple Loosestrife and Garden Loosestrife on Lake Burien

Surveyed July and September 2009

Figure 8. Lake Burien 2009 purple loosestrife and garden loosestrife locations (source: Messick 2010).

Three non-native plants designated as noxious weeds were observed among the emergent types. Purple loosestrife (*Lythrum salicaria*) and garden loosestrife (*Lysimachia vulgaris*) were observed along much of the north and south shores (see Figure 7). Reed canarygrass (*Phalaris arundinacea*) was also observed at one location on the north shore and one location on the east shore. Lake Burien residents have recently been working with Katie Messick of King County to map and control these noxious weeds. A map of the most recent survey conducted in July and September 2009 by King County is presented in Figure 8 (Messick 2010). The number of observed plants was similar, but many plant locations have changed since the 1999 survey.

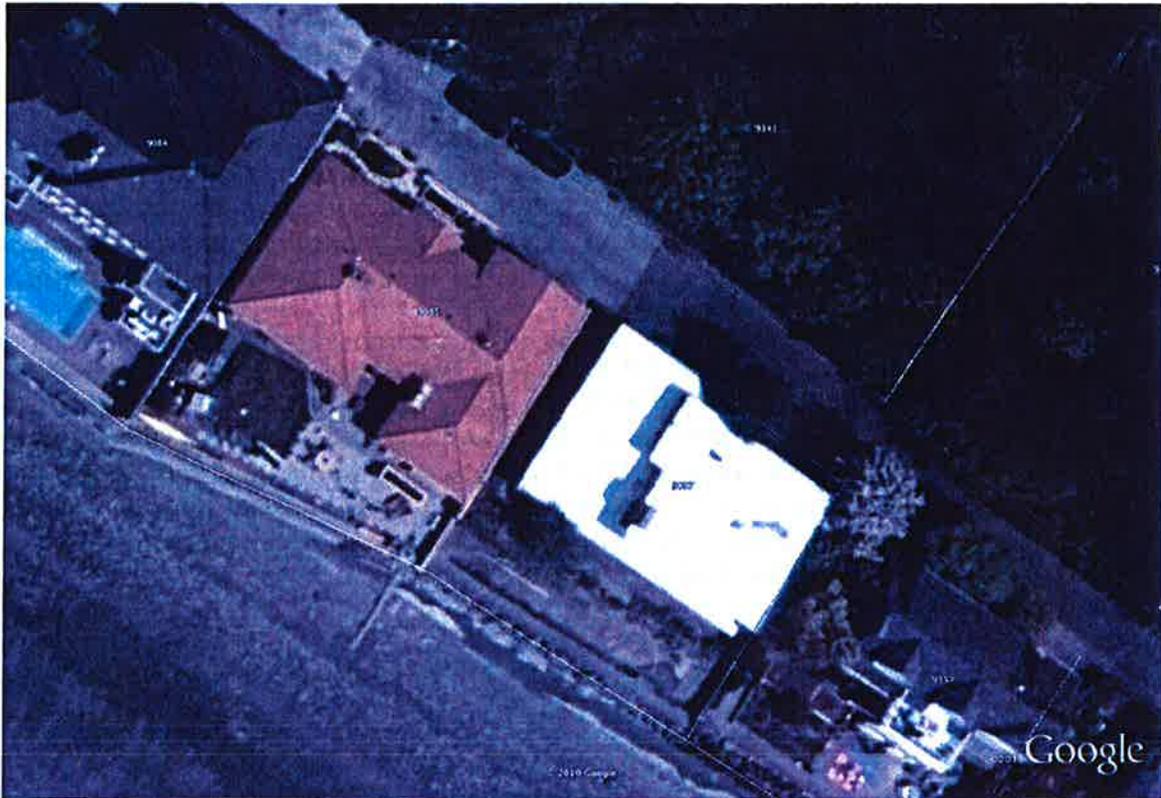
**Figure 1.1: An aerial image of 6 properties along 30th Ave SW**

This evaluation also relies on high quality aerial images such as those available in Google Earth. Figure 1.1, which shows four waterfront homes and two undeveloped upland parcels on a steep slope along 30th Ave SW, provides an example of the level of detail that is readily available.

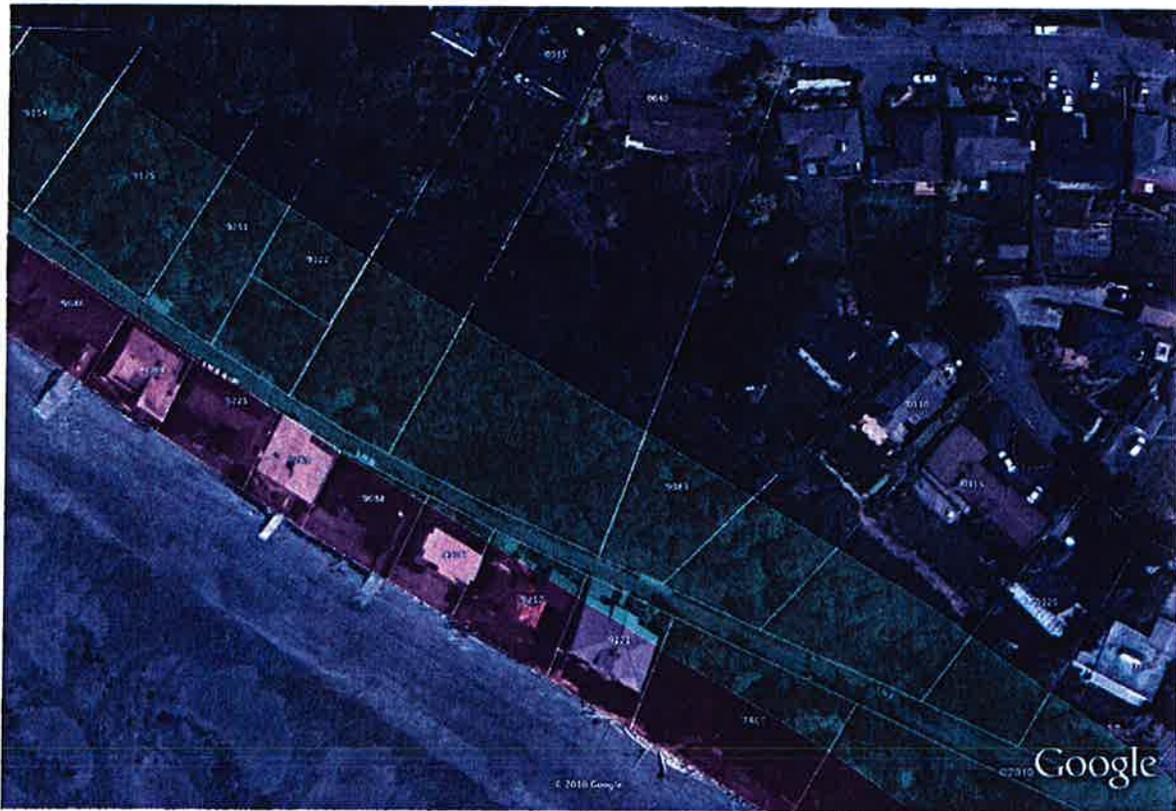
**Figure 2.1: A portion of 30th Ave SW**

The location of waterfront homes between the OWHM and upland bluff is a principal geographic feature in this segment that appears with some frequency throughout the Burien shoreline. Figure 2.1 is provided to help visualize an example of these features. This figure includes a depiction of the SMP jurisdiction in green and the proposed no-touch area in red.

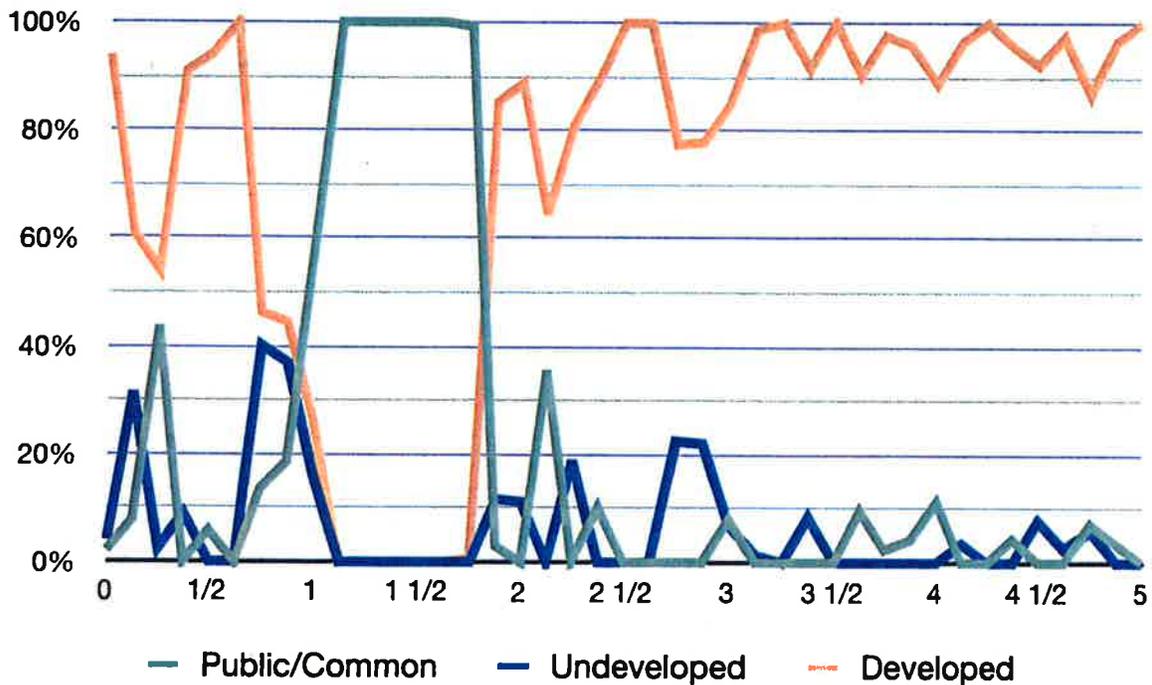
**Figure 3.1 Public/Common vs Private land along the Shoreline**

The x-axis represents distance, in miles, from the border between Seattle and Burien. The left end of the axis is Seattle and the right end is Normandy Park. The y-axis is the percentage of land area of each type as a fraction of the total area of the SMP jurisdiction. Seahurst Park begins at a little more than 1 mile from Seattle, and the remainder of the developed shoreline stretches from about 2.25 miles to Normandy Park.

The public/common land includes parks, street ends, and tract parcels. The first spike near Seattle is the two tract parcels at the southeast end of the Seola Lane / 30th Ave segment, the second major spike is Seahurst Park, the third spike is Eagle Landing Park, and the remaining spikes are street ends and minor tract parcels. Slightly over 20% of the total area is in the public trust. Almost all of this land is in a natural condition and it is unlikely that this land will become more fully developed in a minimum 20 year planning period. In fact this land provides the best opportunity for restoration activities.

Figure 3.1 shows the percentage of land area within the SMP jurisdiction that is in public vs. private ownership. For privately owned land this chart indicates whether the land is on a developed parcel or an undeveloped parcel.

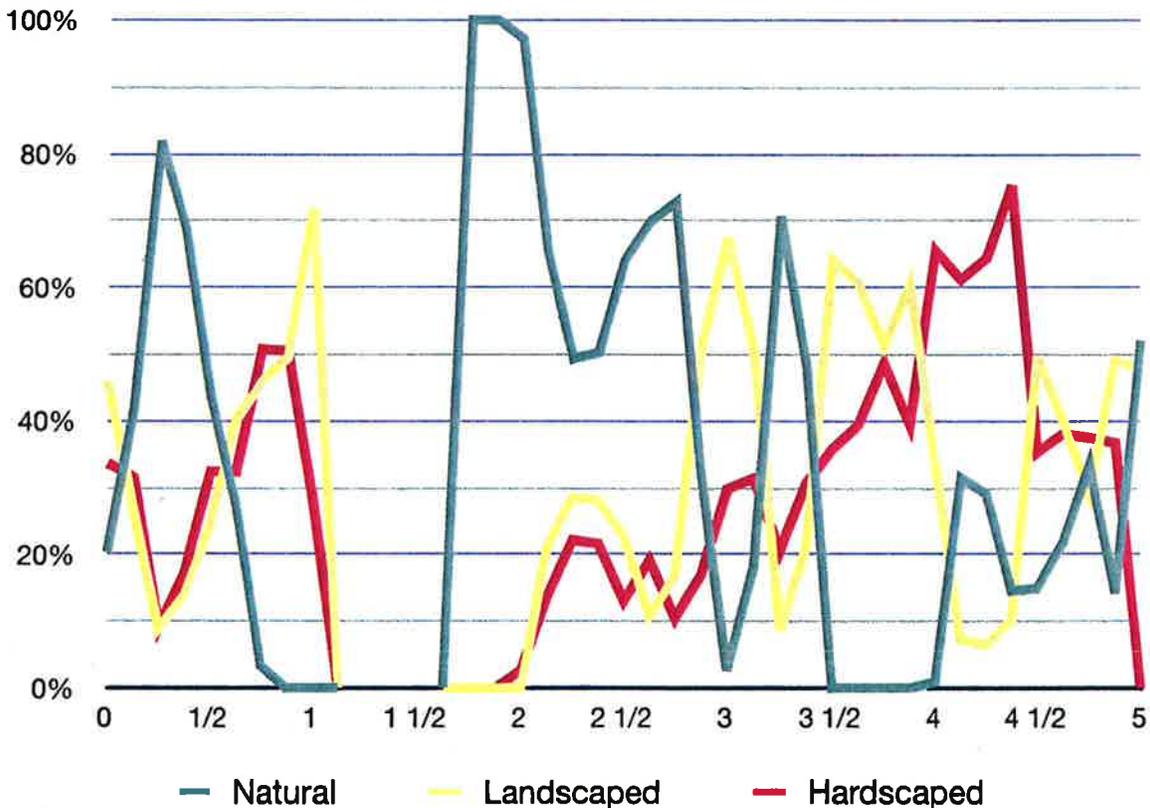
Figure 3.2 Conditions on privately owned developed properties

The total percentage of land coverage sums to 100% for most of this chart. The primary exception is the roughly 3/4 of a mile of Seahurst Park where there is no private property at all which is depicted as 0% for all coverage types.

Approximately 70% of the area is assigned to properties that have been developed exclusively with single family residences and their appurtenant structures; a priority use in the SMA. Figure 3.2 shows the patterns of use for the developed properties. A gap is shown for Seahurst Park.

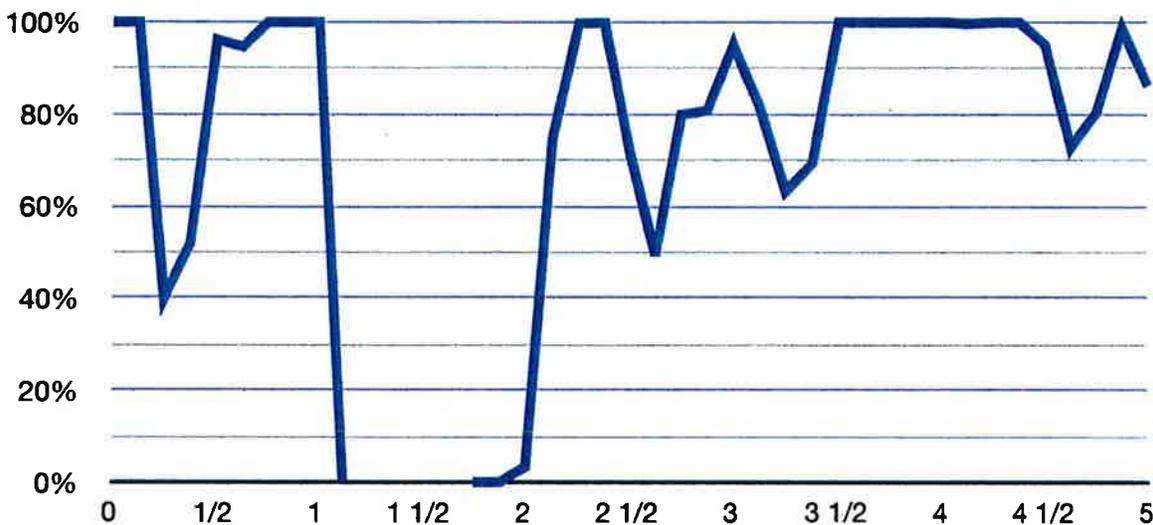
**Figure 3.3 Altered conditions within the first 65' from OHWM**

Figure 3.3 clarifies this point by focussing on the altered conditions within privately developed properties for the first 65' from OHWM. This is the area that is proposed as a no-touch area in the Burien draft SMP. Almost 85% of the private developed land within 65' of OHWM is already in an altered condition. There are significant sections of the shoreline where 100% of this area is altered. The first trough around 1/4 miles from Seattle is the steep slope along Shorewood Drive that has tended to force homes to the top of the bluff. The large trough at 1.5 miles is, of course, Seahurst Park which is publicly owned. The remaining peaks and troughs correspond almost perfectly to the position of the hill. The land is fully developed near OHWM when the slope allows and relatively natural when the home has been forced to the top of the bluff. This is the area that is currently proposed as a no-touch area in Burien draft SMP update.

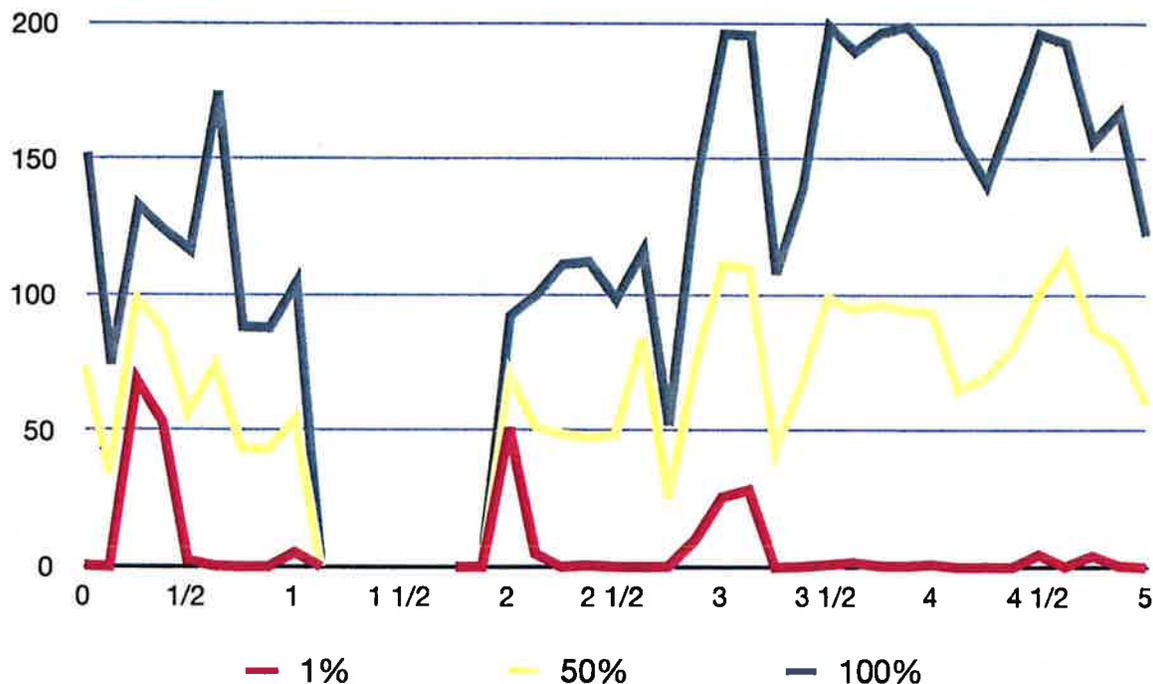
Figure 3.4 provides an indication of how altered the conditions are based on distance from OHWM. The red line (1%) indicates the distance where altered conditions are first encountered. The green line (100%) indicates the furthest point of altered land in SMP jurisdiction. Finally the yellow line (50%) indicates the distance travelled to cover half of the total altered land.

For much of the marine shoreline, altered conditions begin immediately at OWHM. Exceptions occur primarily where steep bluffs extend all the way to OHWM in which case the altered conditions are pushed up the bluff.

For much of the first 2.5 miles of shoreline, and ignoring Seahurst Park, the furthest point of altered land is around 100' to 125' from OHWM. The remaining distance is observed to be steep slopes that are in a largely natural condition.

One is more likely to find altered conditions within the full 200' as one continues south along the shore. The region near the tip of Three Tree Point, approximately 3.8 miles from Seattle, is highly altered for the entire 200' from OHWM. This is reflected in the figure with the 1% point at about 2', the 50% point at 100', and the far point at 200'.

The average distance to the start of the altered condition on privately owned land is 5', the average distance to the 50% level is approximately 75', and the 100% level averages approximately 145'. Note carefully that these averages disregard all public/common land. This quantifies the intuition that the steep bluffs have tend to push the primary residence towards OHWM or else to the top of the bluff and outside of SMP jurisdiction. Outside M2, there is not an existing functioning riparian buffer for most of the shoreline. Defining a generic no-touch area of 65' will not change this and will not contribute to the No Net Loss standard in the SMP guidelines.

**Figure 3.4 Distance Ranges of Altered Condition on Private Property**

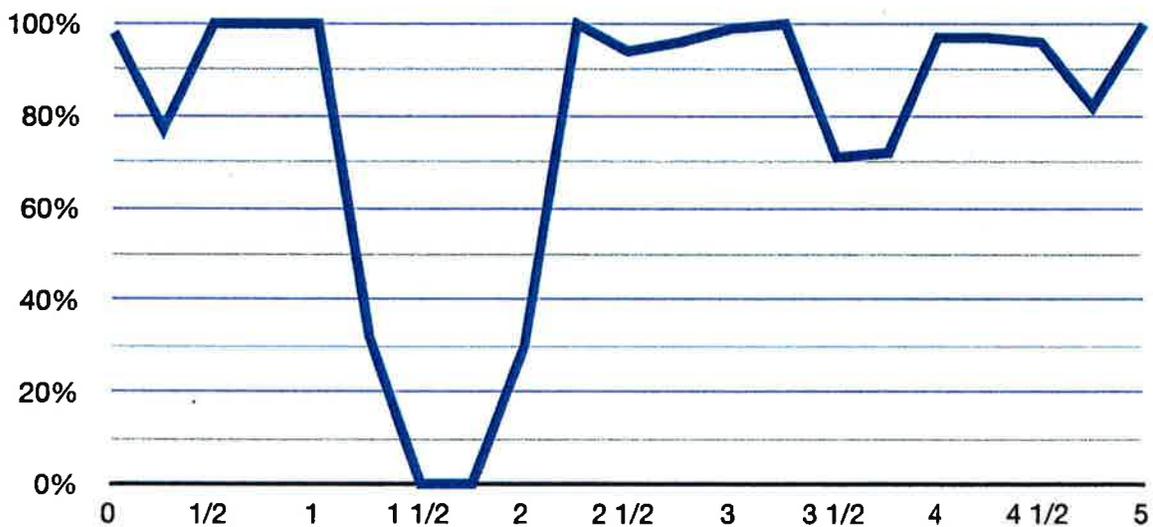
The second dip depicted in the chart is in the Three Tree Point Lane segment of M3. As described in section 2.3, this is one of the few developed segments where the edge of the properties averages approximately 5' landward of the current OHWM. In sum, the buildable undeveloped lots that we are aware of are either at the top of a bluff or are already armored.

Figure 3.5 Presence of armoring along the Shoreline (mi)
