**City of Burien**  
Community Center Annex

**Facility Condition Report**

**December 16, 2019**

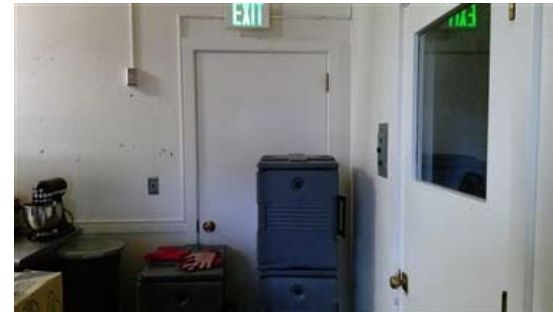
#### Deficient Material: Hardware

Hardware is non-ADA compliant (original 1952 brass door knobs). Glass vision units do not appear to be tempered safety glass. Lock cylinders are starting to fail and some tenants have changed locks (preventing master key access).

Note ALL kitchen exit doors were locked, including being blocked by equipment, preventing egress in an emergency. All exit doors should be operable in the path of egress and not require a key to exit the space in the event of an emergency.

Replace door hardware with ADA compliant latchsets and hardware. Vision panels do not appear to be tempered safety glazing; replace. Clear pathway to exits. Provide code-compliant hardware at all exit doors. Test for hazardous materials (e.g. lead-based paint).

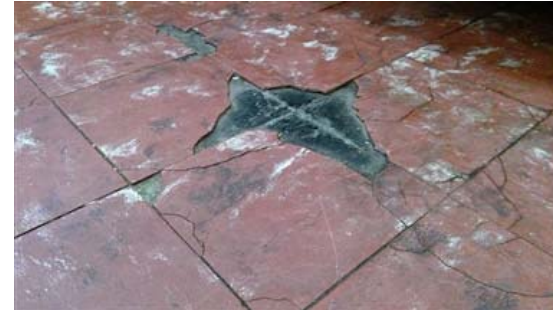
#### Deficient Material: Vinyl Composite Tile (VCT)

Areas of 9 x 9 tile broken and popping loose in kitchen.

Note: Hazardous materials (asbestos) in tile, floor, and base adhesives suspected due to the age of the building, tile unit size, and visual appearance.

This is especially a concern in the kitchen that appears to be in use and exhibits some of the most degraded conditions.

Test for asbestos in tile and in adhesives. Abate or encapsulate if asbestos is present.

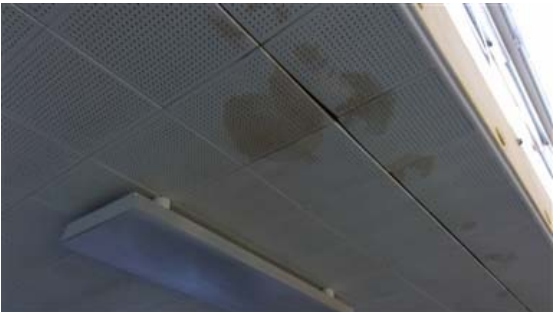
Deficient Material: Acoustic Ceiling Tile

12 x 12 acoustical tile. Many tiles are water damaged and warped. Some glue-up ceiling tiles are missing or broken.

Note: Possible hazardous materials (asbestos) suspected due to the age of the building and visual appearance of acoustical tiles and adhesive (where tiles are missing).

Test for asbestos and abate tiles and adhesives. Replace with new acoustical ceiling treatment.

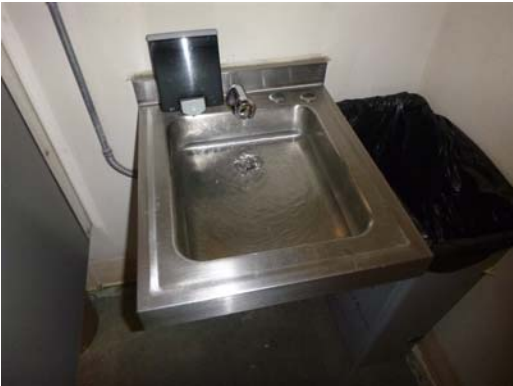
**Deficient Material: Plumbing fixtures & trim**  
Damaged fixtures and especially trim. Apparent failed point-of-use hot water heater at women's lavatory hand sink.

**Remedial Action:**  
Repair or replace as needed.

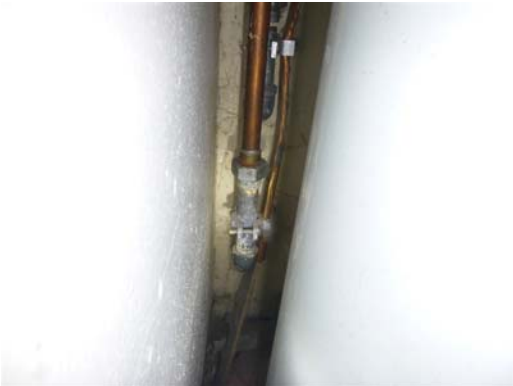
Deficient Material: Galvanized pipe

Replace galvanized pipe with copper and/or PEX.

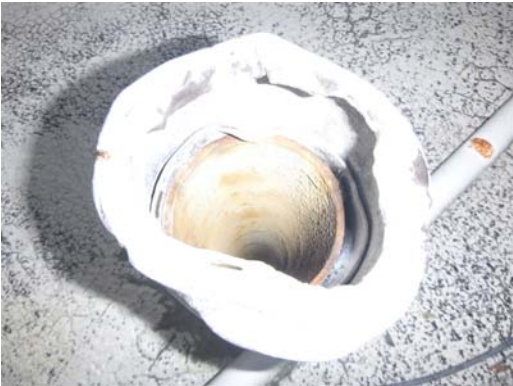
Deficient Material: Drain, waste & vent piping  
Reported increasing backups.

Remedial Action:  
Clean, test, inspect, and repair DW&V piping.

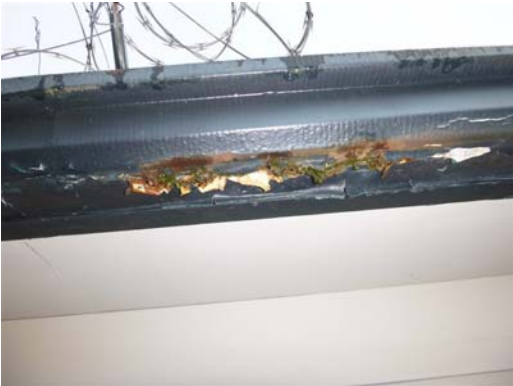
**Deficient Material: Gutter & downspout**  
Missing, corroded, dirty, or damaged gutter and downspout.

**Remedial Action:**  
Clean, repair, or replace as needed.

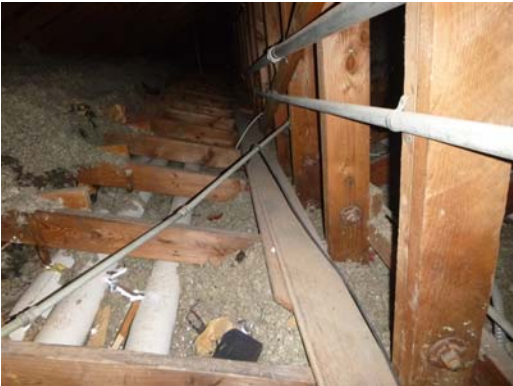
**Deficient Material: Hot water piping**  
Aging heating hot water piping.

**Remedial Action:**  
Clean, test, inspect, and service or replace heating hot water distribution piping, including isolation valves, high-point vents, lower point drains, and related devices and fittings.

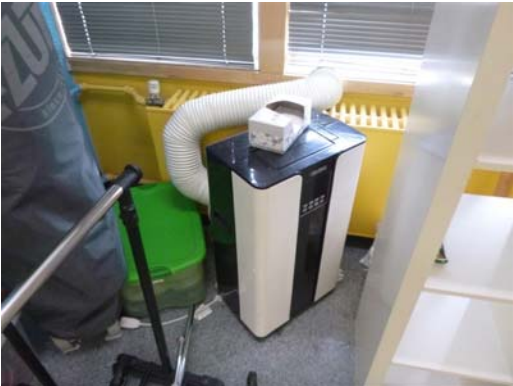
**Deficient Material: Air conditioning**  
Portable air conditioning in former classroom spaces.

**Remedial Action:**  
Install two ceiling fans in high ceiling area and/or restore operability of high ceiling windows.

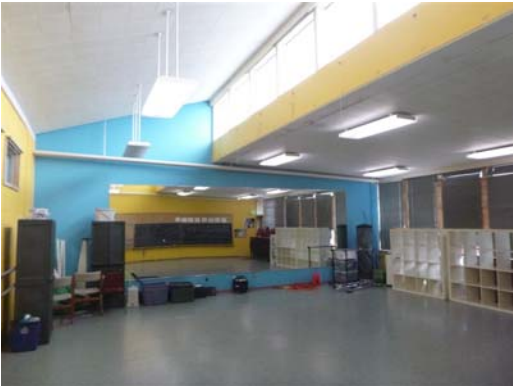
Deficient Material: Ventilation

Cross and stack natural ventilation of original classroom spaces made inoperable by replacement of original clerestory operable windows with fixed polycarbonate sheets.

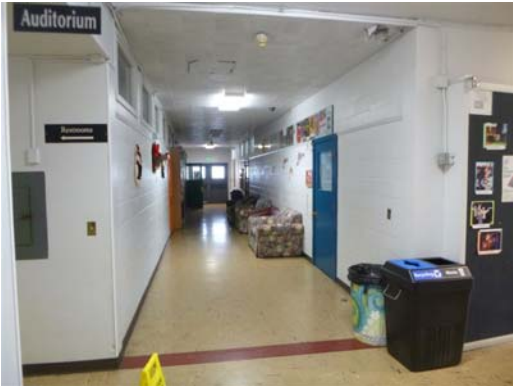
Deficient Material: Ventilation system  
No apparent corridor ventilation.

Remedial Action:  
Install corridor ventilation per code.

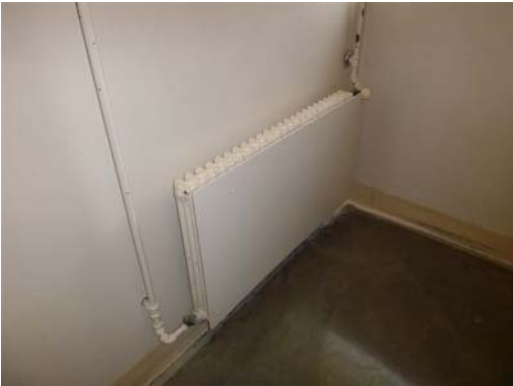
**Deficient Material: Convectors**  
Heating hot water convector units aging.

**Remedial Action:**  
Clean and service.

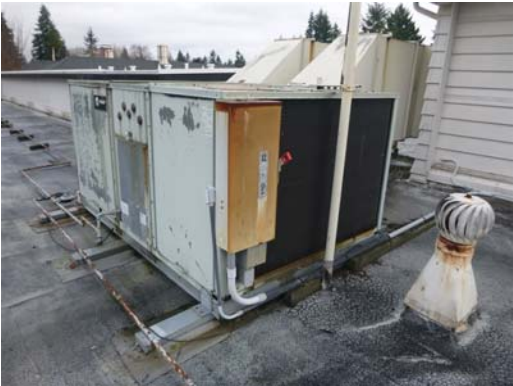
Deficient Material: Roof Top Unit

Auditorium rooftop gas-pack unit at end of life with intermittent operation and failing components.

Replace.

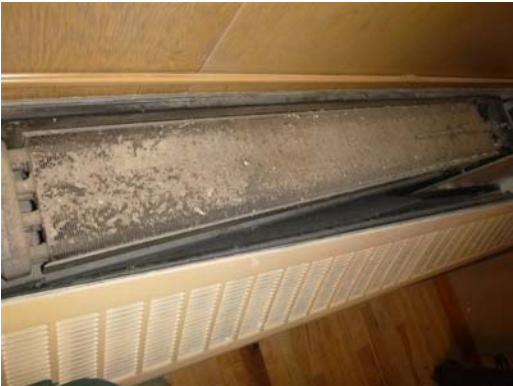
Deficient Material: Unit ventilators

Original unit ventilators are dusty, dirty with damaged internal components and unclear outside air function.

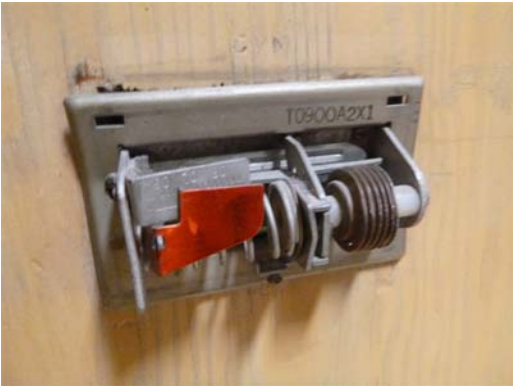
Deficient Material: Controls

Little or no control other than manual for most spaces;  
reportedly failing auditorium rooftop unit controls.

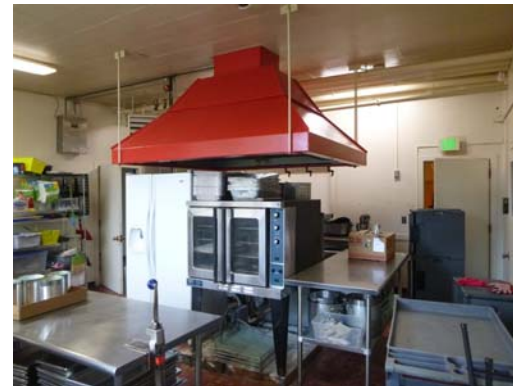
#### Deficient Material: Kitchen exhaust

Kitchen grease hood exhaust fan discharge louvers appear frozen shut and/or fan belt failed. No dish washer hood, no apparent make-up air system other than operable windows, and unclear safety interlocks with gas and power to cooking equipment. Refrigerators are located under the hood as well.

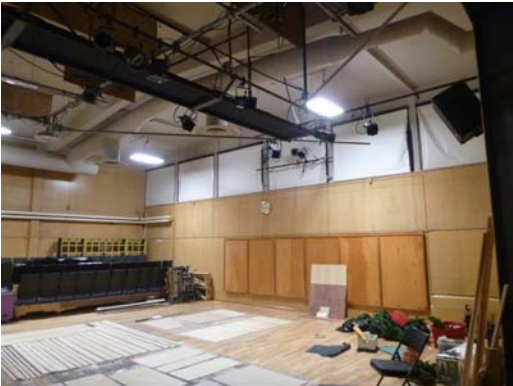
Deficient Material: Fire Sprinkler  
No fire sprinkler for most areas.

Remedial Action:  
Install per code.

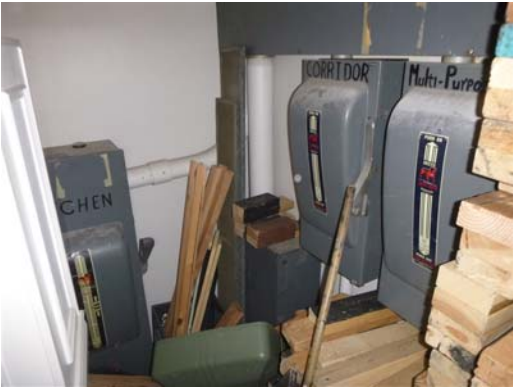
Deficient Material: Distribution

Obsolete original (1952) Bulldog disconnects and distribution panels, with increasing circuit breaker failures and parts difficult or impossible to obtain.

Replace obsolete distribution equipment and cabling in conjunction with new service to building; either part of overall site power upgrade or just for South Annex.

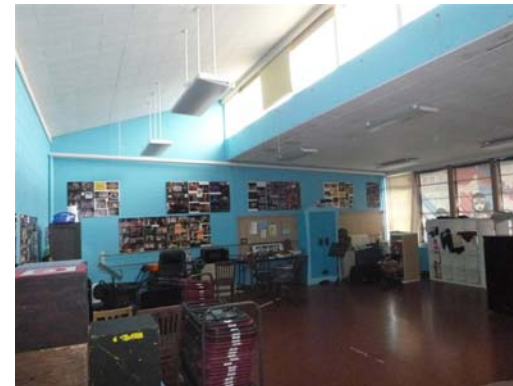
#### Deficient Material: Light fixtures

Failed or failing ballasts and lamps, some cracked, damaged, missing, or discolored lenses.

Repair or replace ballasts, lamps, and damaged or missing lenses. Replace any marginal switches.

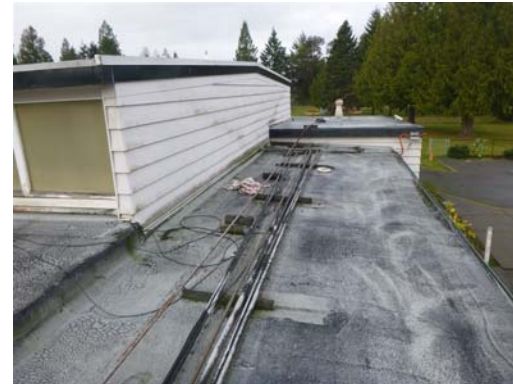
#### Deficient Material: Cable plant

Variety of loose conduits and cables on roof, some suspected abandoned, others failing or damaged.

Demolish abandoned conduit or cabling. Repair or replace materials needed for continued service.

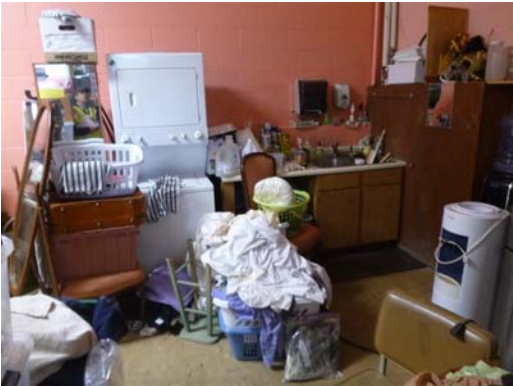
Deficient Material: Laundry equipment

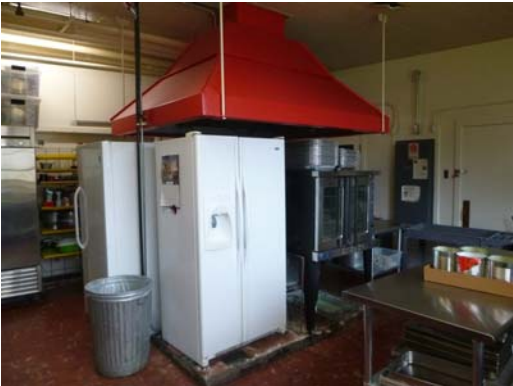
**Deficient Material: Kitchen equipment**  
Aging commercial kitchen equipment.

**Remedial Action:**  
Budget for replacement as equipment begins to fail; assume replacements will be energy- and water-efficient.

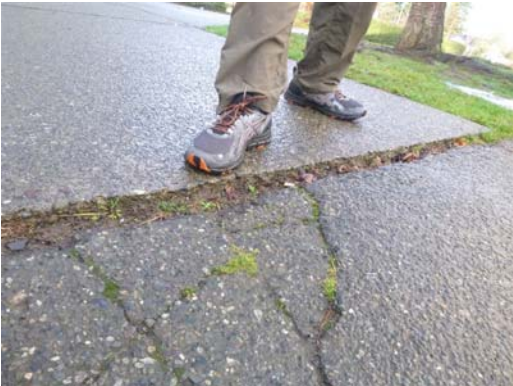
Deficient Material: Concrete Paving

Settlement of slab at area between buildings presenting a trip hazard and non-ADA accessible route.

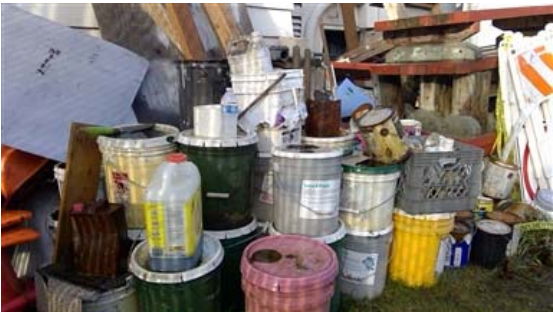
Deficient Material: Other

Area of outdoor storage of materials may present a hazard and potential leaching of materials.

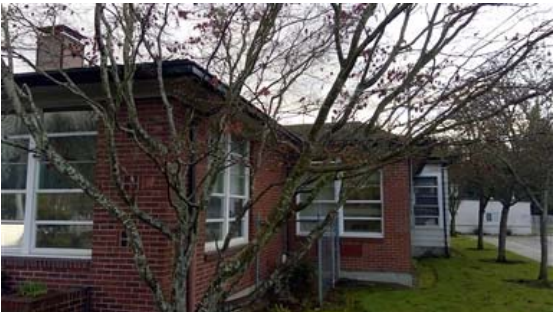
Deficient Material: Trees

Trim limbs away from over the roof and away from structure. Remove other areas of landscaping around perimeter that provide places for individuals to hide or camp.

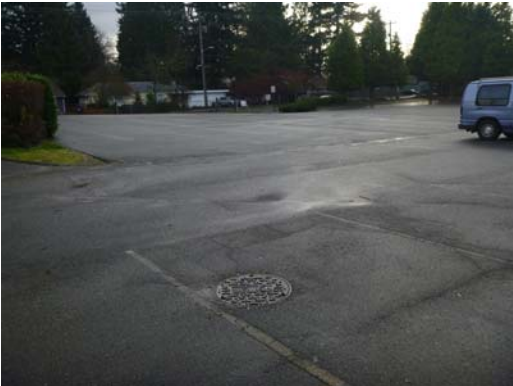
Deficient Material: Side sewer

Failing side sewer at end of life with increasing failures and backups.

Fully clean, test, and inspect side sewer, including connections to both North Annex and South Annex. Repair or replace as needed to fully renew.

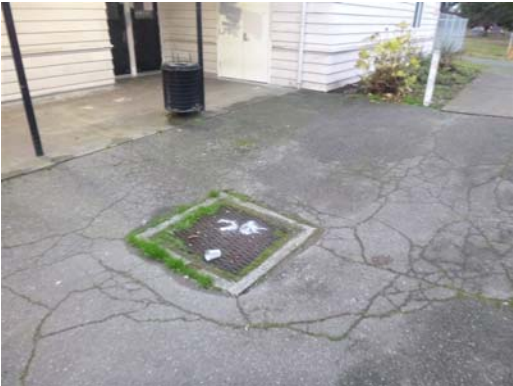
**Deficient Material: Catch basin cover**  
Catch basin grate aging and rusting.

**Remedial Action:**  
Budget for replacement prior to failure.

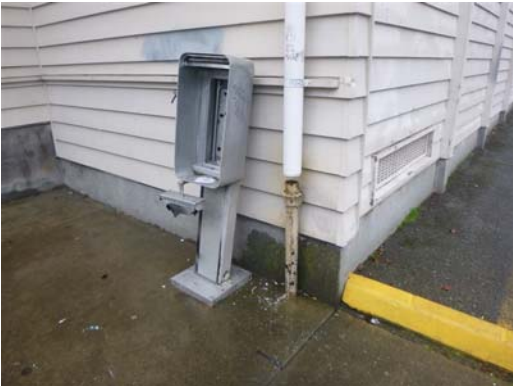
Deficient Material: Storm Drain

Multiple roof drain storm connections are damaged, collapsed, and backed up, resulting in localized erosion and flooding.

Replace damaged roof drain storm connections.

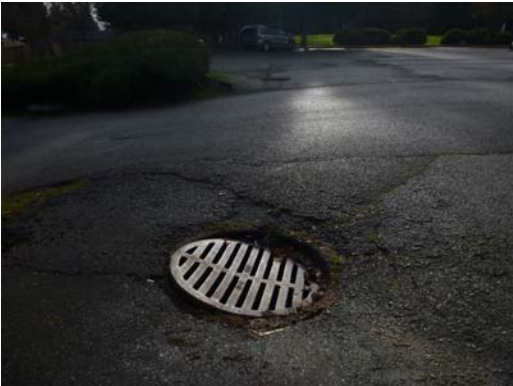
Deficient Material: Storm Drain  
Damaged catch basin covers.

Remedial Action:  
Repair covers.

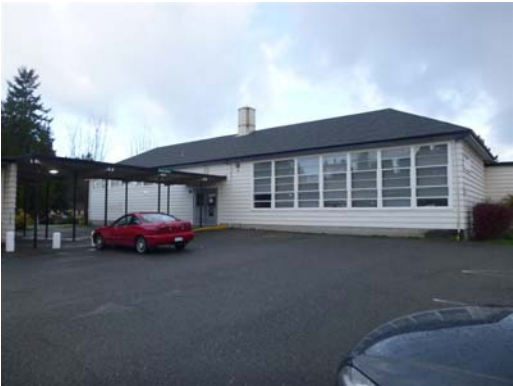
Deficient Material: Heating water piping

Replace prior to failure.

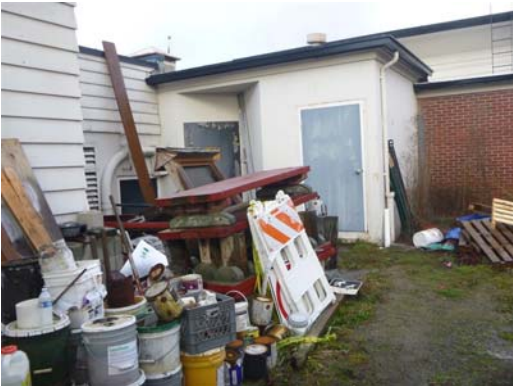
Deficient Material: Electrical service
